# FACILITY CONDITION ASSESSMENT & ENERGY AUDIT

**City of Glendora**  
116 East Foothill Boulevard  
Glendora, California 91741  
Michael Sledd

*February 19, 2024*

Big Dalton Canyon Park Daycamp/Restrooms  
2041 Big Dalton Canyon Road  
Glendora, California 91741

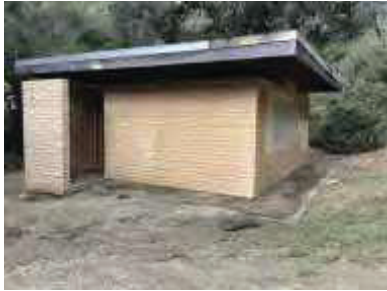
### Exterior Walls in Poor condition.

any painted surface  
 Restroom Building Big Dalton Canyon Park  
 Daycamp/Restrooms Restrooms Building  
 Exterior

The building's paint is mismatched and aged. - AssetCALC ID: 7215848

Uniformat Code: B2010  
 Recommendation: **Prep and Paint in 2024**

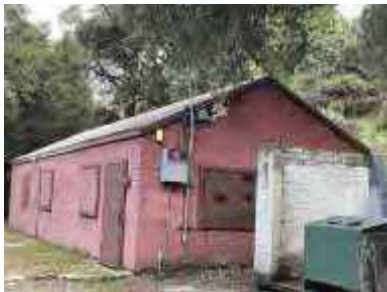
### Exterior Walls in Poor condition.

any painted surface  
 Daycamp Building Big Dalton Canyon Park  
 Daycamp/Restrooms Day Camp Building  
 Exterior

The building's paint is in a state of disrepair and necessitates attention. Repainting is recommended. - AssetCALC ID: 7215806

Uniformat Code: B2010  
 Recommendation: **Prep and Paint in 2024**

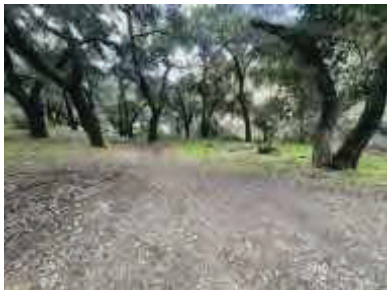
There are reportedly problems with site drainage. A professional civil engineering study is recommended to determine the source of problems and possible remedies. Due to the unknown nature of the needed repairs, no costs have been included for this work.

### Recommended Follow-up Study: Civil, Site Drainage

Study recommended to investigate reported site drainage problems. - AssetCALC ID: 7359007

Uniformat Code: P2030  
 Recommendation: **Evaluate/Report in 2024**

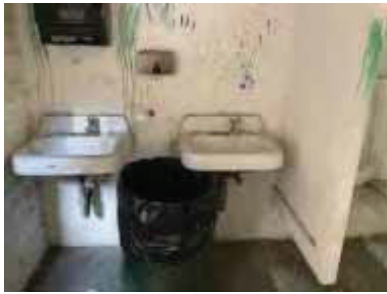
Videoscoping of the plumbing piping is recommended due to the reported problems with clogged piping. A cost for this has been included. The plumbing piping is assumed to be original to the buildings. A cost for replacing the piping is included.

### Recommended Follow-up Study: Plumbing, Video Survey

Video scoping recommended to investigate reported clogging problems - AssetCALC ID: 7359008

Uniformat Code: P2030  
Recommendation: **Evaluate/Report in 2024**

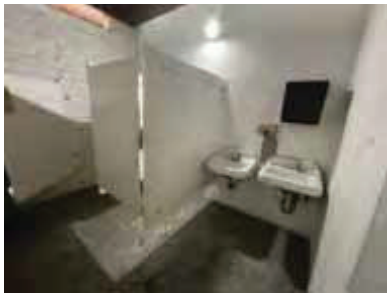
### Wall Finishes in Poor condition.

any surface  
Restroom Building Big Dalton Canyon Park  
Daycamp/Restrooms Throughout Restrooms  
Building

The interior building's paint is soiled and missing in areas. - AssetCALC ID: 7215851

Uniformat Code: C2010  
Recommendation: **Prep and Paint in 2024**

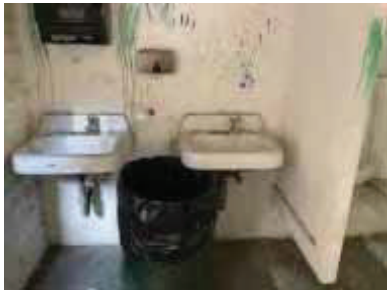
### Flooring in Poor condition.

any surface, with Paint or Sealant  
Restroom Building Big Dalton Canyon Park  
Daycamp/Restrooms Restrooms Building Floor

Resealing the concrete floor is recommended as the existing seal has deteriorated, with bare spots. - AssetCALC ID: 7215855

Uniformat Code: C2030  
Recommendation: **Prep and Paint in 2024**

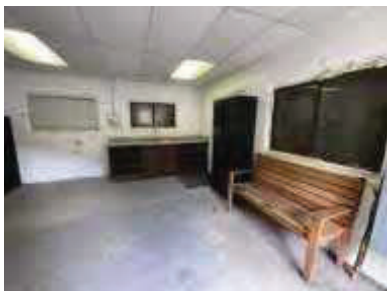
### Wall Finishes in Poor condition.

any surface  
Daycamp Building Big Dalton Canyon Park  
Daycamp/Restrooms Throughout Day Camp  
Building

The interior building's paint is deteriorating and requires attention. Repainting is recommended. - AssetCALC ID: 7215850

Uniformat Code: C2010  
Recommendation: **Prep and Paint in 2024**

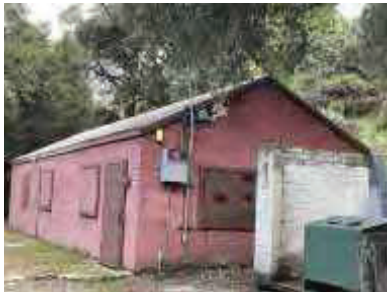
### Fences and Gates in Poor condition.

Fence, any Painted Surface  
Site Big Dalton Canyon Park  
Daycamp/Restrooms Dumpster Enclosure.

Painting the retaining wall is recommended. - AssetCALC ID: 7216327

Uniformat Code: G2060  
Recommendation: **Prep and Paint in 2024**

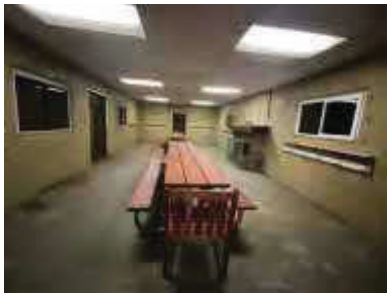
### Flooring in Poor condition.

any surface, with Paint or Sealant  
Daycamp Building Big Dalton Canyon Park  
Daycamp/Restrooms Day Camp Building Floor

Resealing the concrete floor is recommended as the existing seal has deteriorated. - AssetCALC ID: 7215854

Uniformat Code: C2030  
Recommendation: **Prep and Paint in 2024**

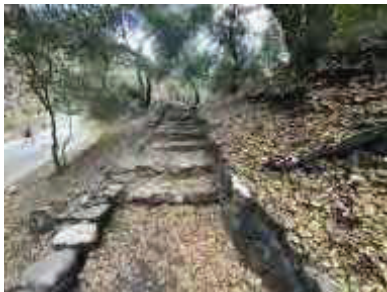
The site and buildings are not accessible to persons with disabilities, and no accessibility features are present. Bureau Veritas recommends a study be performed to take measurements, provide additional itemized details, research local requirements, and, if necessary, estimate the scope and cost of any required improvements. The cost of this study is included in the cost tables. Due to the lack of measurements and itemized findings at this point in time, the costs for any possible subsequent repairs or improvements are not currently included.

### ADA Miscellaneous

Level III Study, Includes Measurements  
Site Big Dalton Canyon Park  
Daycamp/Restrooms Site

Uniformat Code: Y1090  
Recommendation: **Evaluate/Report in 2023**
