# FACILITY CONDITION ASSESSMENT & ENERGY AUDIT

**City of Glendora**  
116 East Foothill Boulevard  
Glendora, California 91741  
Michael Sledd

*February 14, 2024*

Finkbiner Park Skate/Tennis  
166 North Minnesota Avenue  
Glendora, California 91741

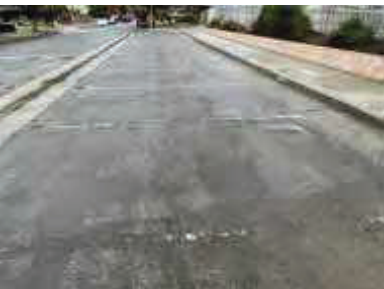
**Roadways in Poor condition.**

Significant alligator cracking and potholes - AssetCALC ID: 7197660

Uniformat Code: G2010  
Recommendation: **Mill and Overlay in 2025**

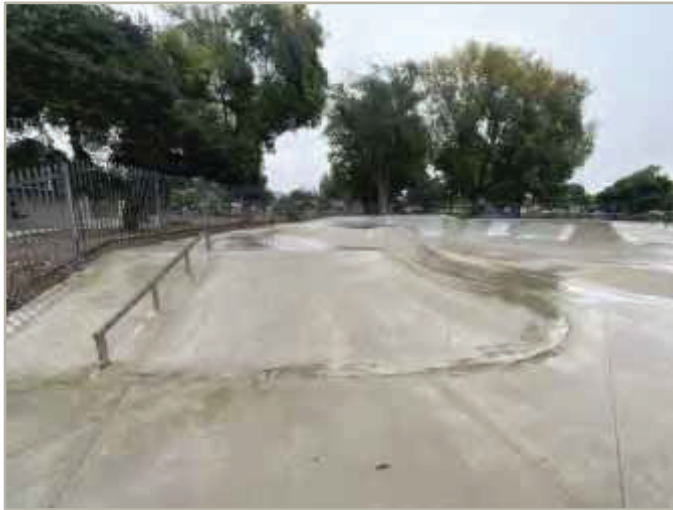
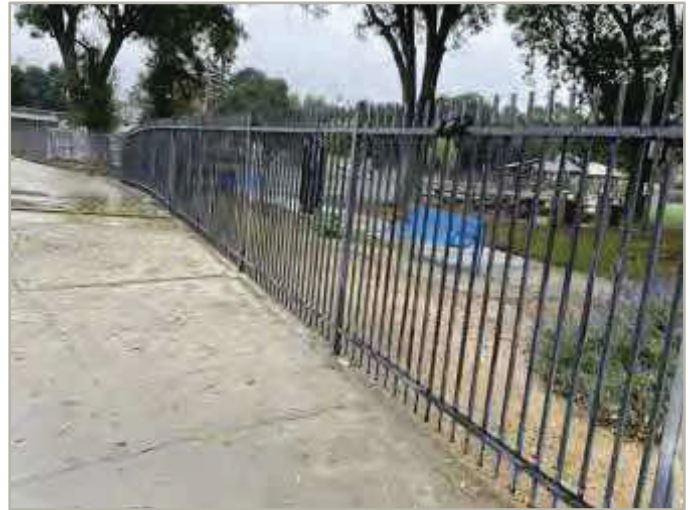
B-6. Skate Park

Skate Park			
<b>Asset Type</b>	Athletic Fields – Skate Park		
<b>Asset Location</b>	Middle of Finkbiner Park		
<b>Overall Condition</b>	Fair		
<i>Component</i>	<i>Description</i>	<i>Quantity</i>	<i>Condition</i>
<b>Athletic Surfaces and Courts</b>	Skate Park, Concrete Pavement, Maintain	2000 SF	Poor
<b>Athletic Surfaces and Courts</b>	Skate Park, Concrete Pavement, Replace/Install	15490 SF	Fair
<b>Signage</b>	Exterior/Site, Guide and Directional Wall-Mounted, Replace/Install	1 EA	Good
<b>Fences and Gates</b>	Fence, Metal Tube 6', Replace	480 LF	Fair
<b>Accessibility</b>	Potential accessibility issues were not observed at this asset. Refer to Appendix D and the previous study for more details.		
<b>Key Issues and Findings</b>	Cracks in the pavement causing potential trip hazards

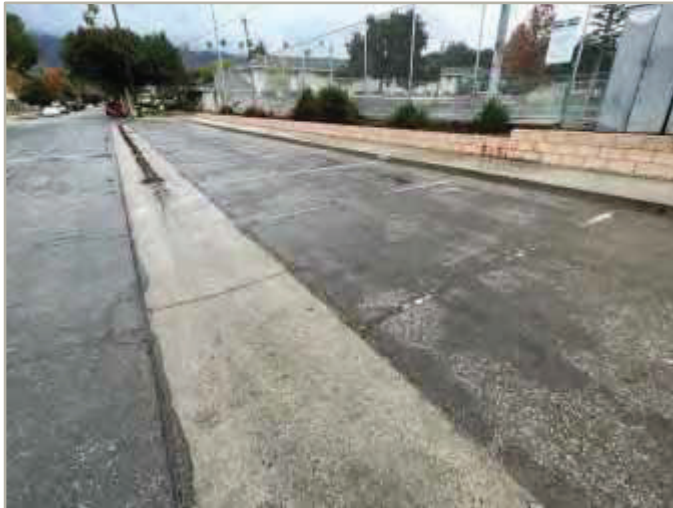
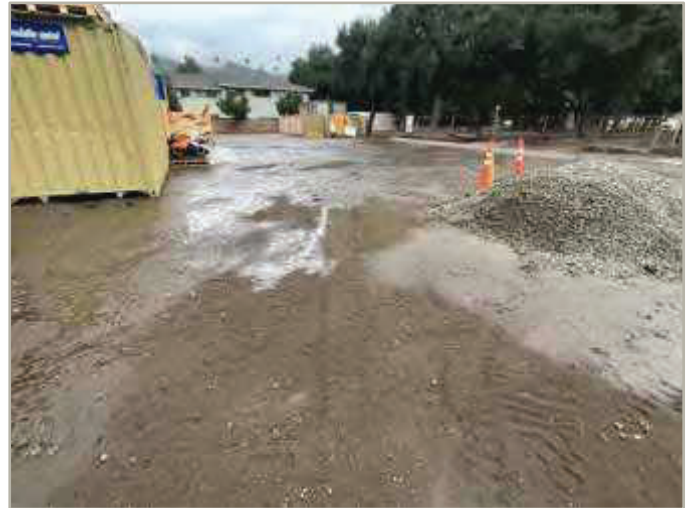
B-8. General Site

<b>General site</b>	
<b>Landscaping and Topography</b>	Limited landscaping features; irrigation not present Low to moderate site slopes throughout
<b>Storm Water Management</b>	Surface drainage to developed and undeveloped surroundings
<b>Accessibility</b>	Potential accessibility issues were not observed at this asset. Refer to Appendix D and the previous study for more details.
<b>Key Issues and Findings</b>	Significant asphalt pavement cracking

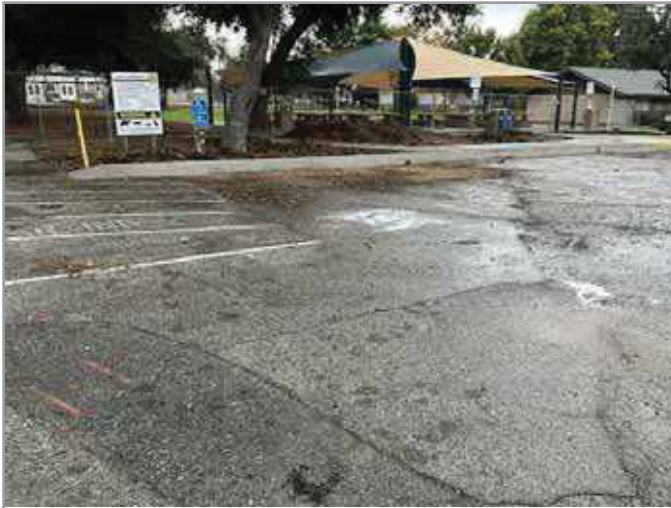
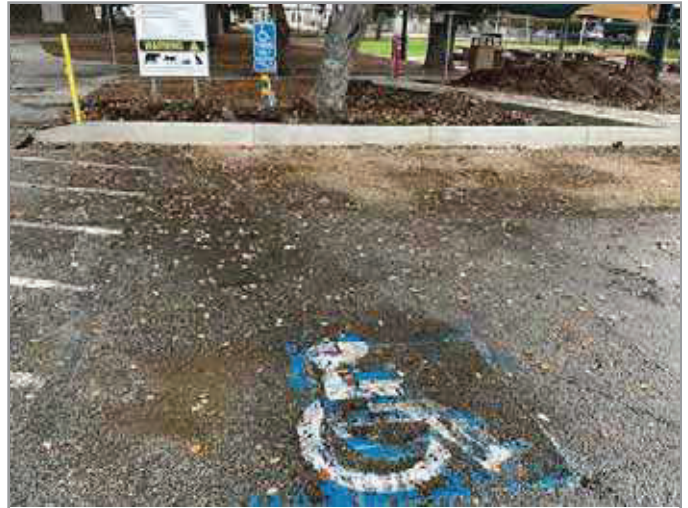
Question		Yes	No	NA	Comments
1	Does the required number of standard ADA designated spaces appear to be provided ?	✗			Construction is in progress and as reported ADA compliance will be considered.
2	Does the required number of van-accessible designated spaces appear to be provided ?	✗			
3	Are accessible spaces on the shortest accessible route to an accessible building entrance ?	✗			
4	Does parking signage include the International Symbol of Accessibility ?	✗			
5	Does each accessible space have an adjacent access aisle ?	✗			
6	Do parking spaces and access aisles appear to be relatively level and without obstruction ?	✗
