FACILITY CONDITION ASSESSMENT & ENERGY AUDIT

City of Glendora
116 East Foothill Boulevard
Glendora, California 91741
Michael Sledd

Gladstone Park Restrooms
600 East Gladstone Street
Glendora, California 91741

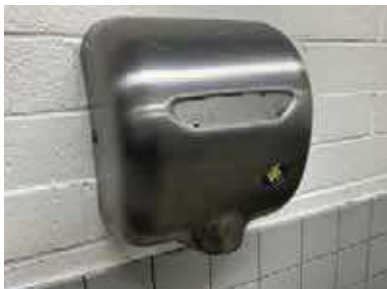
Supplemental Components in Poor Condition.

Hand Dryer, Restroom
Gladstone Park Restrooms

Uniformat Code: D3060
Recommendation: **Replace in 2025**
