FACILITY CONDITION ASSESSMENT & ENERGY AUDIT

La Fetra Senior Center
333 East Foothill Boulevard
Glendora, California 91741

February 16, 2024

December 11, 2023

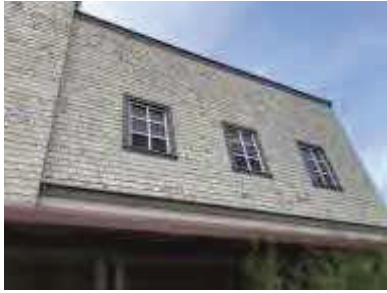
Exterior Walls in Poor condition.

any painted surface
La Fetra Senior Center Building Exterior

Paint chipping observed throughout - AssetCALC ID: 7162794

Uniformat Code: B2010
Recommendation: **Prep and Paint in 2025**

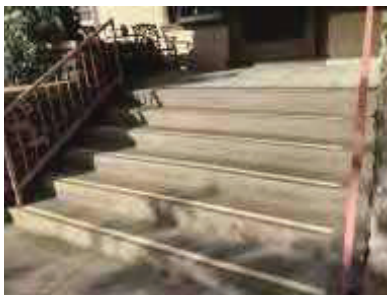
Site Stairs and Ramps in Poor condition.

Steps, Concrete (per LF of nosing)
La Fetra Senior Center Older Building Exterior

Concrete cracking observed on stairs. Trip hazard. - AssetCALC ID: 7162799

Uniformat Code: G2030
Recommendation: **Replace in 2025**

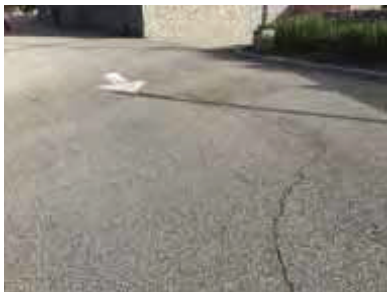
Parking Lots in Poor condition.

Pavement, Asphalt
La Fetra Senior Center Site

Isolated locations of asphalt cracking - AssetCALC ID: 7162802

Uniformat Code: G2020
Recommendation: **Seal and Stripe in 2025**

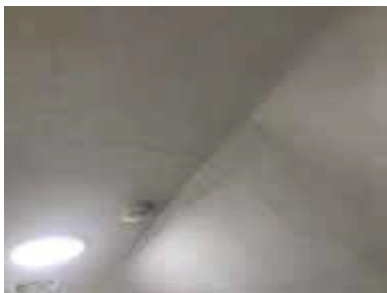
Cracking was observed on the interior ceiling, walls, and basement wall. While there have been no reported issues of building movement, the facility is quite old and may have potential issues. A professional engineer must be retained to analyze the existing condition, provide recommendations and, if necessary, estimate the scope and cost of any required repairs. The cost of this study is included in the cost tables. A budget allocation based on the area of the building is included in the tables, awaiting the outcomes of the engineering study on the foundation.

Civil, General Design
La Fetra Senior Center Interior

Interior wall and ceiling cracking observed in various areas around the building. Some cracking on basement concrete wall. A study is recommended to see if there may be any potential foundation issues. - AssetCALC ID: 7162772

**Recommended Follow-up Study:
Civil, General Design**

Uniformat Code: P2030
Recommendation: **Replace in 2023**

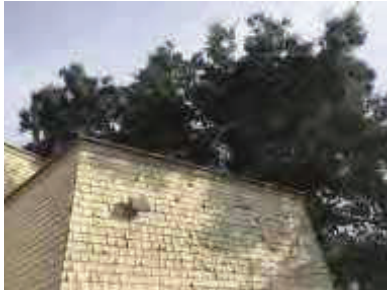
Landscaping in Poor condition.

Mature Trees, Removal/Trimming
La Fetra Senior Center Site

Mature tree growth over asphalt roof. Trimming is recommended to prevent damage to roof. - AssetCALC ID: 7162775

Uniformat Code: G2080
Recommendation: **Repair in 2023**

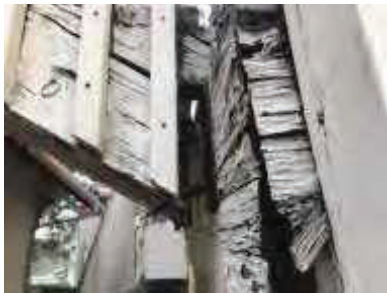
Stairs in Poor condition.

Wood, Exterior
La Fetra Senior Center Older Building Exterior

Stairs are blocked from use. Wood is splitting apart. Removal is recommended. - AssetCALC ID: 7162795

Uniformat Code: B1080
Recommendation: **Replace in 2025**

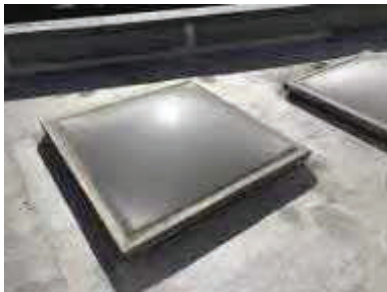
Roof Skylight in Poor condition.

per unit, up to 20 SF
La Fetra Senior Center Roof

Skylights are leaking - AssetCALC ID: 7162734

Uniformat Code: B3060
Recommendation: **Replace in 2025**

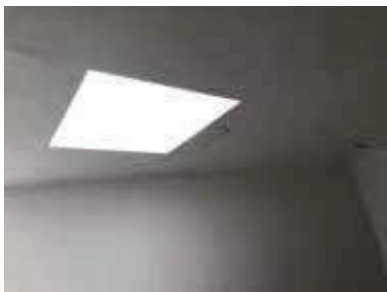
Ceiling Finishes in Poor condition.

Gypsum Board/Plaster
La Fetra Senior Center Throughout

Ceiling leak damage observed in isolated locations. Repair recommended. - AssetCALC ID: 7182075

Uniformat Code: C2050
Recommendation: **Replace in 2025**

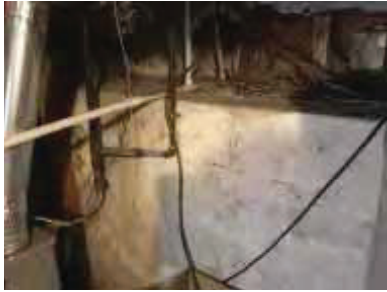
Foundation System

La Fetra Senior Center Foundation

This is a cost allowance pending results of engineering study on foundation. - AssetCALC ID: 7182076

Recommendation: **Repair in 2028**
