# FACILITY CONDITION ASSESSMENT & ENERGY AUDIT

**City of Glendora**  
116 East Foothill Boulevard  
Glendora, California 91741  
Michael Sledd

Ole Hammer Park  
359 North Live Oak Avenue  
Glendora, California 91741

*February 19, 2024*

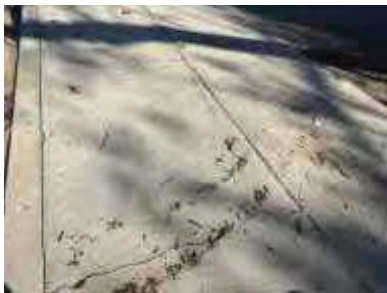
### Sidewalk in Poor condition.

Concrete, Small Areas/Sections  
Ole Hammer Park Park

The concrete sidewalks show signs of wear, with cracks and displaced sections posing potential tripping hazards. To enhance safety, it's recommended to consider replacing these affected areas. - AssetCALC ID: 7193376

Uniformat Code: G2030  
Recommendation: **Replace in 2025**

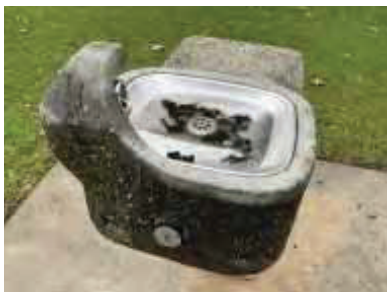
### Drinking Fountain in Poor condition.

Site  
Ole Hammer Park Park Center

The drinking fountain is aged and inoperable. - AssetCALC ID: 7193381

Uniformat Code: D2010  
Recommendation: **Replace in 2024**

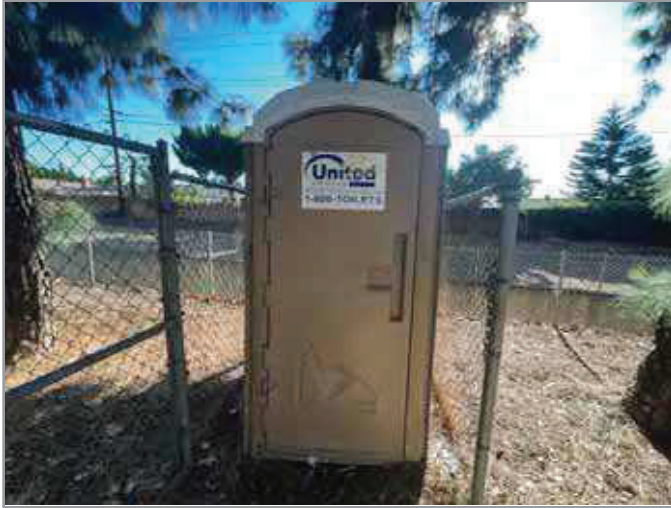
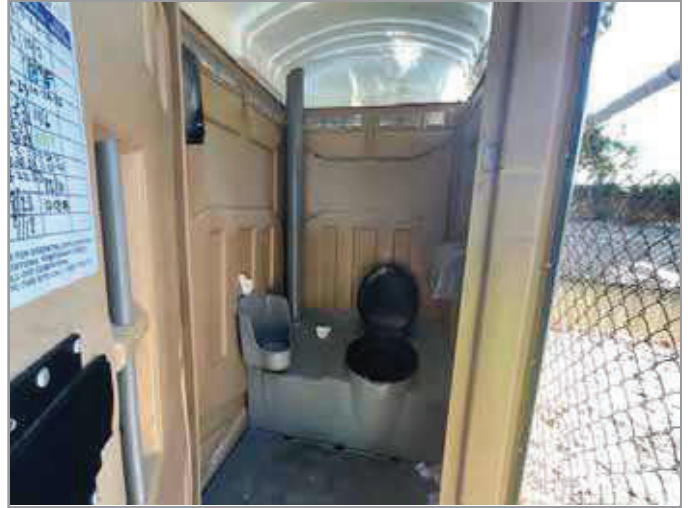
Question		Yes	No	NA	Comments
1	Do publicly accessible toilet rooms appear to have a minimum compliant floor area ?		X		Rented port-a-potty provided, not accessible type
2	Does the lavatory appear to be mounted at a compliant height and with compliant knee area ?			X	
3	Does the lavatory faucet have compliant handles ?			X	
4	Is the plumbing piping under lavatories configured to protect against contact ?			X	
5	Are grab bars provided at compliant locations around the toilet ?			X	
6	Do toilet stall doors appear to provide the minimum compliant clear width ?			X

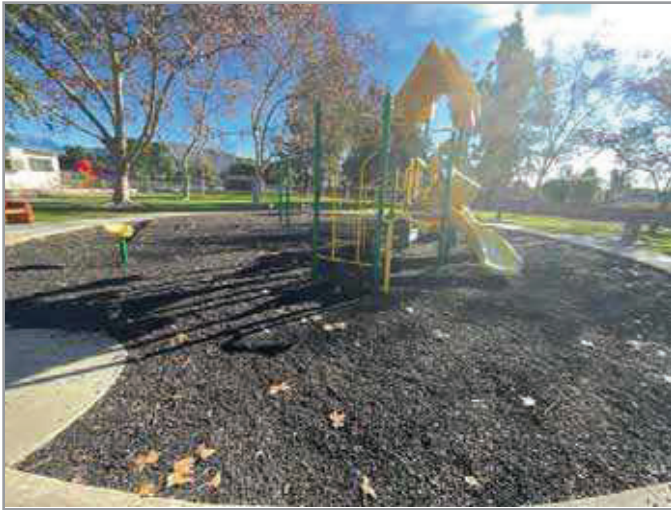
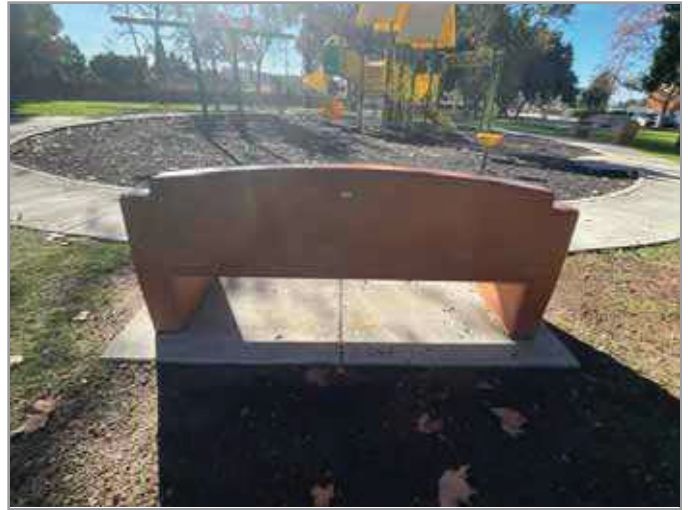
Question		Yes	No	NA	Comments
<b>1</b>	Is there an accessible route to the play area / s?		<b>×</b>		Accessible surface does not extend to play equipment - poured play surface would provide accessibility
<b>2</b>	Has the play area been reviewed for accessibility ?		<b>×</b>		
<b>3</b>	Are publicly accessible swimming pools equipped with an entrance lift ?			<b>×</b>
