FACILITY CONDITION ASSESSMENT

Pay N Play Racquetball
155 West Dawson Avenue
Glendora, California 91741

158691.23R000-012.379

February 2, 2024

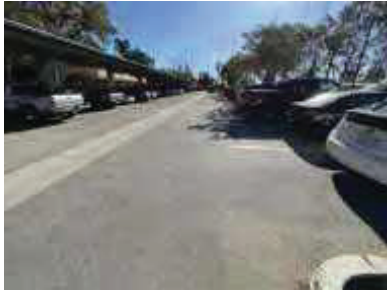
Parking Lots in Poor condition.

Pavement, Asphalt
Pay N Play Racquetball Site

Isolated asphalt pavement cracking. - AssetCALC ID: 7133422

Uniformat Code: G2020
Recommendation: **Seal and Stripe in 2025**

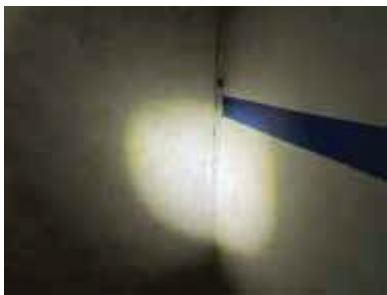
Recommended Follow-up Study: Structural, Superstructure

Structural, Superstructure
Pay N Play Racquetball Throughout building

Foundation cracks were identified at various locations inside the building. A cost to hire professional engineer study the cause and analysis of structural integrity is added - AssetCALC ID: 7133429

Uniformat Code: P2030
Recommendation: **Evaluate/Report in 2023**

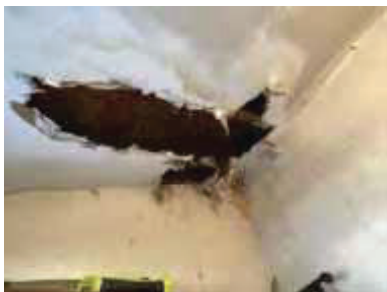
Ceiling Finishes in Poor condition.

Gypsum Board/Plaster
Pay N Play Racquetball Restrooms

Ceiling damage observed in utility closet. Repair is recommended. - AssetCALC ID: 7133423

Uniformat Code: C2050
Recommendation: **Repair in 2023**

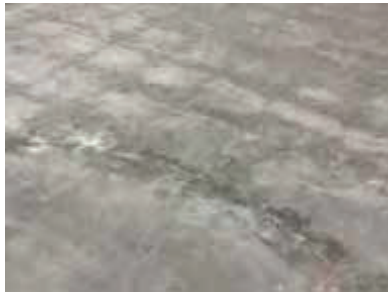
Flooring

Removed tiles in process of replacement - AssetCALC ID: 7133440

Uniformat Code: C2030
Recommendation: **Replace in 2026**
