FACILITY CONDITION ASSESSMENT & ENERGY AUDIT

City of Glendora
116 East Foothill Boulevard
Glendora, California 91741
Michael Sledd

San Gabriel Water Yard/Plant
625 West Hidden Valley Drive
Glendora, California 91702

February 16, 2024

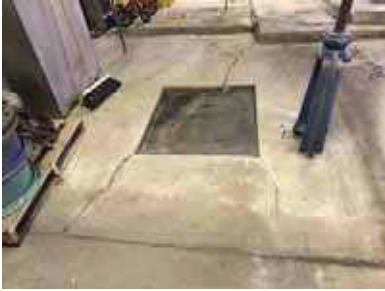
Structural Flooring/Decking in Poor condition.

Concrete
Yard - Storage Building San Gabriel Water
Yard/Plant - Multiple Buildings Storage Building
(Old Booster Building)

Concrete floor cracking in northern half of building - AssetCALC ID: 7164692

Uniformat Code: B1010
Recommendation: **Repair in 2023**

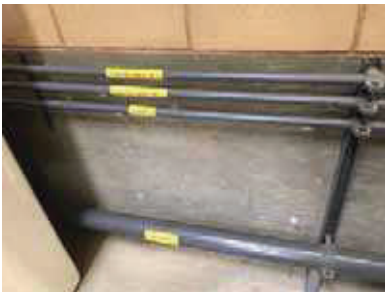
Structural Flooring/Decking in Poor condition.

Concrete
Yard - New Booster Building and Boosters San
Gabriel Water Yard/Plant - Multiple Buildings
Chlorine Room

Flooding leaks on back of chlorine room. Concrete wall is below ground level and not sealed properly. -
AssetCALC ID: 7164635

Uniformat Code: B1010
Recommendation: **Repair in 2023**

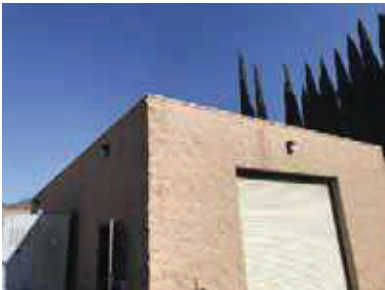
Roofing in Poor condition.

Single-Ply Membrane, EPDM
Yard - Storage Building San Gabriel Water
Yard/Plant - Multiple Buildings Storage Building
(Old Booster Building)

Roof leaks - AssetCALC ID: 7164691

Uniformat Code: B3010
Recommendation: **Replace in 2024**

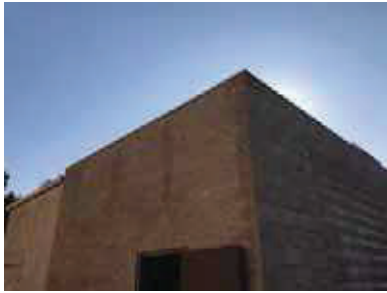
Roofing in Poor condition.

Single-Ply Membrane, EPDM
Plant - Well Building #12E San Gabriel Water
Yard/Plant - Multiple Buildings Roof

Ongoing roof leaks - AssetCALC ID: 7164598

Uniformat Code: B3010
Recommendation: **Replace in 2024**

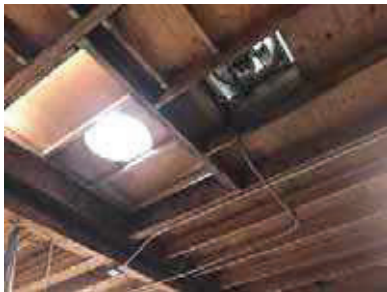
Structural Framing in Poor condition.

Wood, Conventional Stud
Plant - Well Building #12E San Gabriel Water
Yard/Plant - Multiple Buildings Structure

Roof leaks have caused wood rot to the roof structure. - AssetCALC ID: 7164596

Uniformat Code: B1010
Recommendation: **Conventional Stud in 2024**

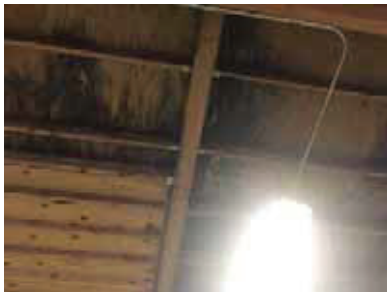
Structural Framing in Poor condition.

Wood, Conventional Stud
Yard - Storage Building San Gabriel Water
Yard/Plant - Multiple Buildings Storage Building
(Old Booster Building)

Roof leaks have caused wood rot to the roof structure - AssetCALC ID: 7164684

Uniformat Code: B1010
Recommendation: **Conventional Stud in 2024**

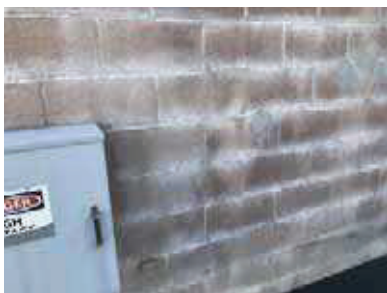
Exterior Walls in Poor condition.

Concrete Block (CMU)
Plant - Well Building #12E San Gabriel Water
Yard/Plant - Multiple Buildings Building Exterior

Cracking on original CMU wall side - AssetCALC ID: 7164600

Uniformat Code: B2010
Recommendation: **Replace in 2025**

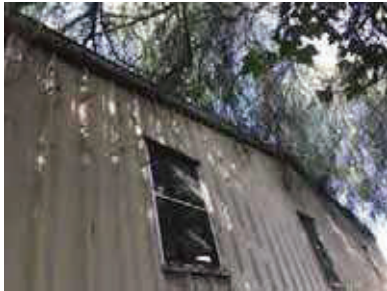
Landscaping in Poor condition.

Mature Trees, Removal/Trimming
Site San Gabriel Water Yard/Plant - Multiple Buildings Site

Mature tree growth on eastern side of building - AssetCALC ID: 7164647

Uniformat Code: G2080
Recommendation: **Repair in 2023**

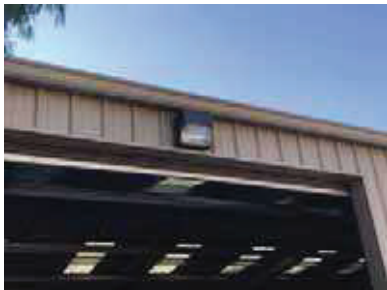
Exterior Fixture w/ Lamp in Poor condition.

any type, w/ LED Replacement
Yard - New Warehouse San Gabriel Water Yard/Plant - Multiple Buildings Building exterior

Metal halide bulbs are burnt out. - AssetCALC ID: 7164648

Uniformat Code: G4050
Recommendation: **Replace in 2025**
