FACILITY CONDITION ASSESSMENT & ENERGY AUDIT

City of Glendora
116 East Foothill Boulevard
Glendora, California 91741
Michael Sledd

Sierra Madre Avenue Water Yard
1051 East Sierra Madre Avenue
Glendora, California 91741

January 9, 2024

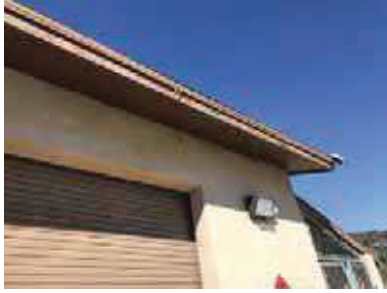
Roofing in Poor Condition.

Any Type, Repairs per Man-Day
Sierra Madre Avenue Water Yard Chemical Building - Building Exterior

Roof edges along overhead door side are deteriorating likely from weather - AssetCALC ID: 7045812

Uniformat Code: B3010
Recommendation: **Repair in 2023**

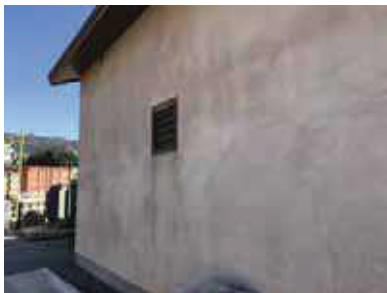
Exterior Walls in Poor Condition.

Concrete
Sierra Madre Avenue Water Yard Chemical Building - Building Exterior

Wall cracking along rear wall - AssetCALC ID: 7045799

Uniformat Code: B2010
Recommendation: **Replace in 2025**

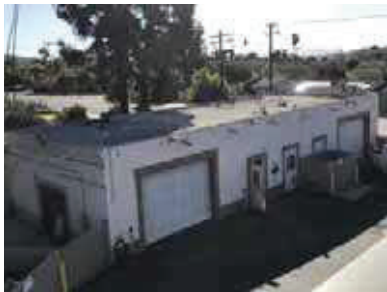
Roofing in Poor Condition.

Built-Up
Sierra Madre Avenue Water Yard Warehouse Roof

Roof leaks have caused extensive interior wood damage - AssetCALC ID: 7045835

Uniformat Code: B3010
Recommendation: **Replace in 2025**

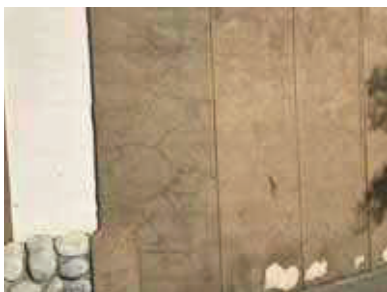
Exterior Walls in Poor Condition.

Concrete
Sierra Madre Avenue Water Yard Warehouse Building Exterior

Concrete wall cracking along front and left elevations - AssetCALC ID: 7045832

Uniformat Code: B2010
Recommendation: **Replace in 2025**

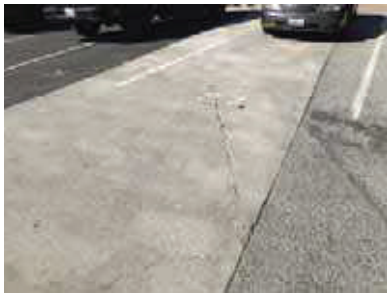
Parking Lots in Poor Condition.

Pavement, Concrete
Sierra Madre Avenue Water Yard Site

Concrete pavement cracking in rear lot - AssetCALC ID: 7045814

Uniformat Code: G2020
Recommendation: **Replace in 2025**

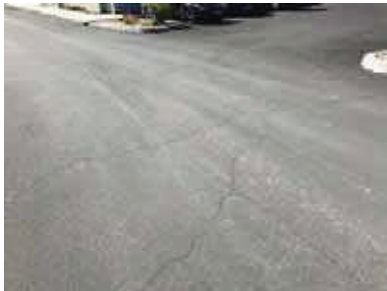
Parking Lots in Poor Condition.

Pavement, Asphalt
Sierra Madre Avenue Water Yard Site Rear Lot

Areas of cracking observed throughout - AssetCALC ID: 7045796

Uniformat Code: G2020
Recommendation: **Seal and Stripe in 2025**

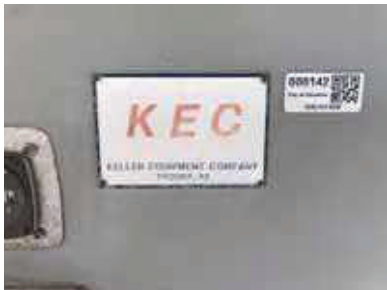
Motor Control Center in Poor Condition.

With Main Breaker
Sierra Madre Avenue Water Yard Well #13E

Breaker is currently not working and needs repair/replacement - AssetCALC ID: 7165014

Uniformat Code: D5020
Recommendation: **Replace in 2024**

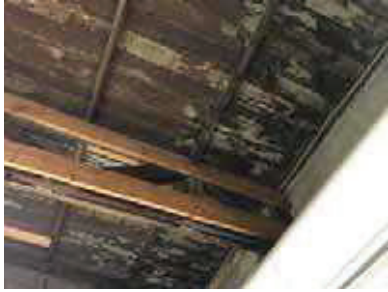
Ceiling Finishes in Poor Condition.

Wood Paneling
Sierra Madre Avenue Water Yard Warehouse Area

Many areas of ceiling leak damage observed in garage storage area - AssetCALC ID: 7045818

Uniformat Code: C2050
Recommendation: **Replace in 2024**

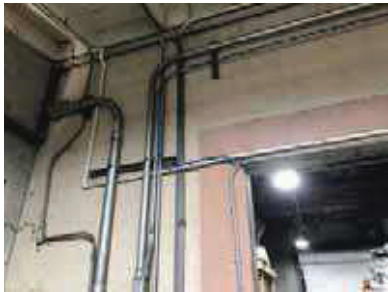
Electrical System in Poor Condition.

Full System Renovation/Upgrade, Low Density/Complexity
Sierra Madre Avenue Water Yard Warehouse Throughout Building

Uniformat Code: D5020
Recommendation: **Replace in 2025**
