# FACILITY CONDITION ASSESSMENT & ENERGY AUDIT

**City of Glendora**  
116 East Foothill Boulevard  
Glendora, California 91741  
Michael Sledd

Transportation Center Building/Garage  
410 East Dalton Avenue  
Glendora, California 91741

*February 16, 2024*

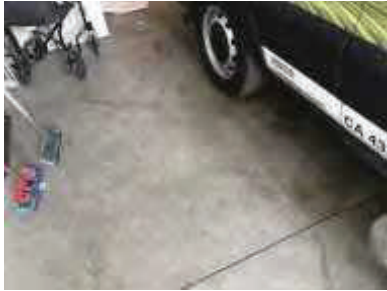
**Structural Flooring/Decking in Poor condition.**

Concrete  
Garage Transportation Center Building/Garage  
Garage

Isolated concrete floor cracking in garage - AssetCALC ID: 7169626

Uniformat Code: B1010  
Recommendation: **Repair in 2023**

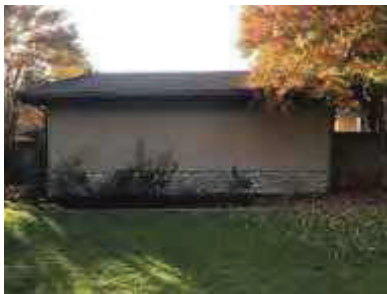
**Roofing in Poor condition.**

Clay/Concrete Tile  
Garage Transportation Center Building/Garage  
Roof

Roof is aged and has a history of leaks - AssetCALC ID: 7194313

Uniformat Code: B3010  
Recommendation: **Replace in 2025**

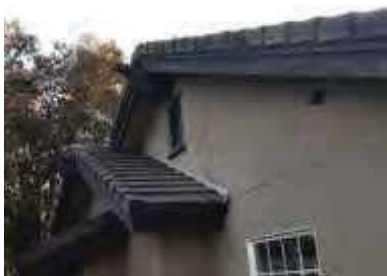
**Roofing in Poor condition.**

Clay/Concrete Tile  
Transportation Center Building Transportation  
Center Building/Garage Roof

History of leaks. Roof is aged and deteriorated - AssetCALC ID: 7169657

Uniformat Code: B3010  
Recommendation: **Replace in 2025**

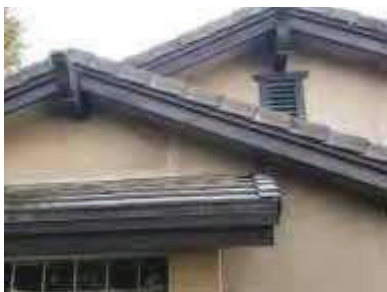
**Exterior Walls in Poor condition.**

any painted surface  
Transportation Center Building Transportation  
Center Building/Garage Building Exterior

Walls are stained and need repainting. - AssetCALC ID: 7169650

Uniformat Code: B2010  
Recommendation: **Prep and Paint in 2025**

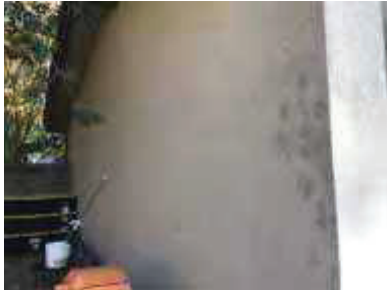
**Exterior Walls in Poor condition.**

Walls are stained and need repainting. - AssetCALC ID: 7169627

Uniformat Code: B2010  
Recommendation: **Prep and Paint in 2025**

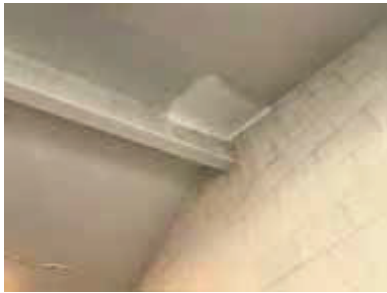
**Ceiling Finishes in Poor condition.**

Ceiling tears caused by roof leaks - AssetCALC ID: 7169632

Uniformat Code: C2050  
Recommendation: **Replace in 2025**
