**REPORT NO. 110383**  
**LIBRARY**

RE: REPORT NO. 110383, LIBRARY

BUILDING SYSTEM EVALUATION  
GENERAL BUILDING PROFILE  
LIBRARY AND CULTURAL CENTER

OWNER: CITY OF GLENDORA  
BUILDING: LIBRARY AND CULTURAL CENTER  
ADDRESS: 140 S. GLENDORA, GLENDORA

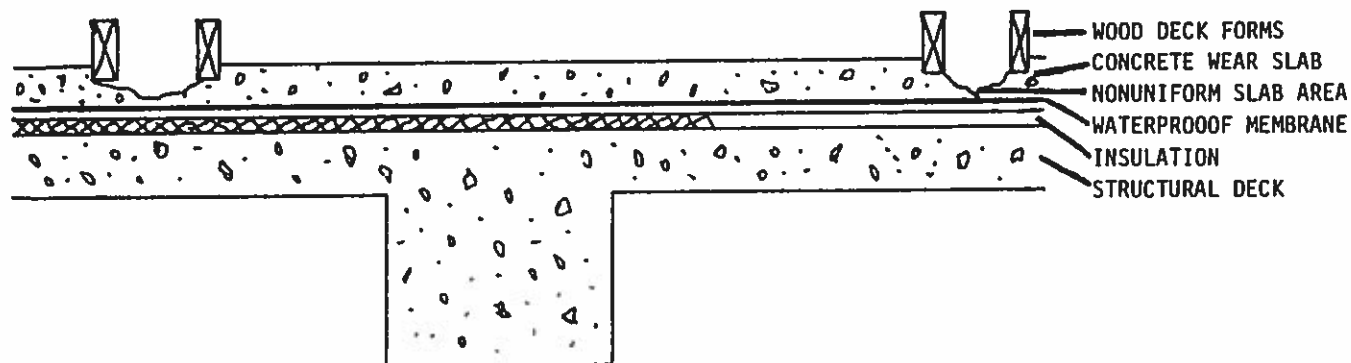
Item 1. The primary problem called to our attention was the cracking of the wear slab and consequent leaks at the upper level of the library. The construction drawings loosely indicate a 1" insulation over the structural concrete slab, capped with a waterproofing membrane. A 2½" concrete wear slab with rows of tiles was poured over the membrane. The wear slab has numerous hairline cracks which are caused by shrinkage of the concrete. There is no evidence that steel reinforcing was used. Removal of some of the tile showed that at three locations, at least, the concrete wear slab was not poured uniformly underneath the 1" reveal used to set the tile. The reveal was then filled (leveled) with mortar.

The illustration below illustrates the forming method for the wear slab squares.

The mortar under the tile had a compressive strength so low that in some instances it could be crushed by hand pressure. This has resulted in the checking and cracking of many of the ceramic tiles which form the deck's pattern.

Item 2. Long breaks in the wear slab could have caused the slab's shrinkage movement to tear the waterproofing membrane. Breaks in the membrane could also have been caused by the workmen during the forming and placement of the slab. Deteriorated or faulty caulking of the joints aggravated the situation.

With the information now available it would be BSE's recommendation to remedy the situation by removing the existing wear slab, waterproofing membrane, and insulation and installing a new mesh-reinforced wear slab with caulked control joints about 10' to 12' on center each way, over a water proofing membraned equipped with a "slip sheet" to break the bond between the slab and the membrane, over new 1" rigid insulation. As an alternate, a urethane synthetic rubber (elastomeric) membrane with a glazed sand finish coat could be installed over the existing wear slab.

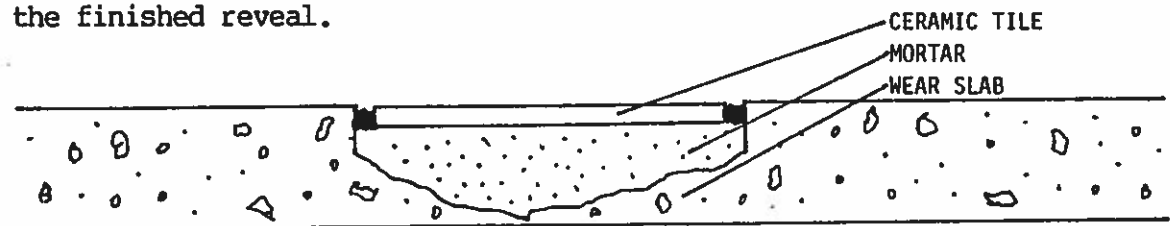
The illustration below illustrates the mortar infill and tile placed in the finished reveal.

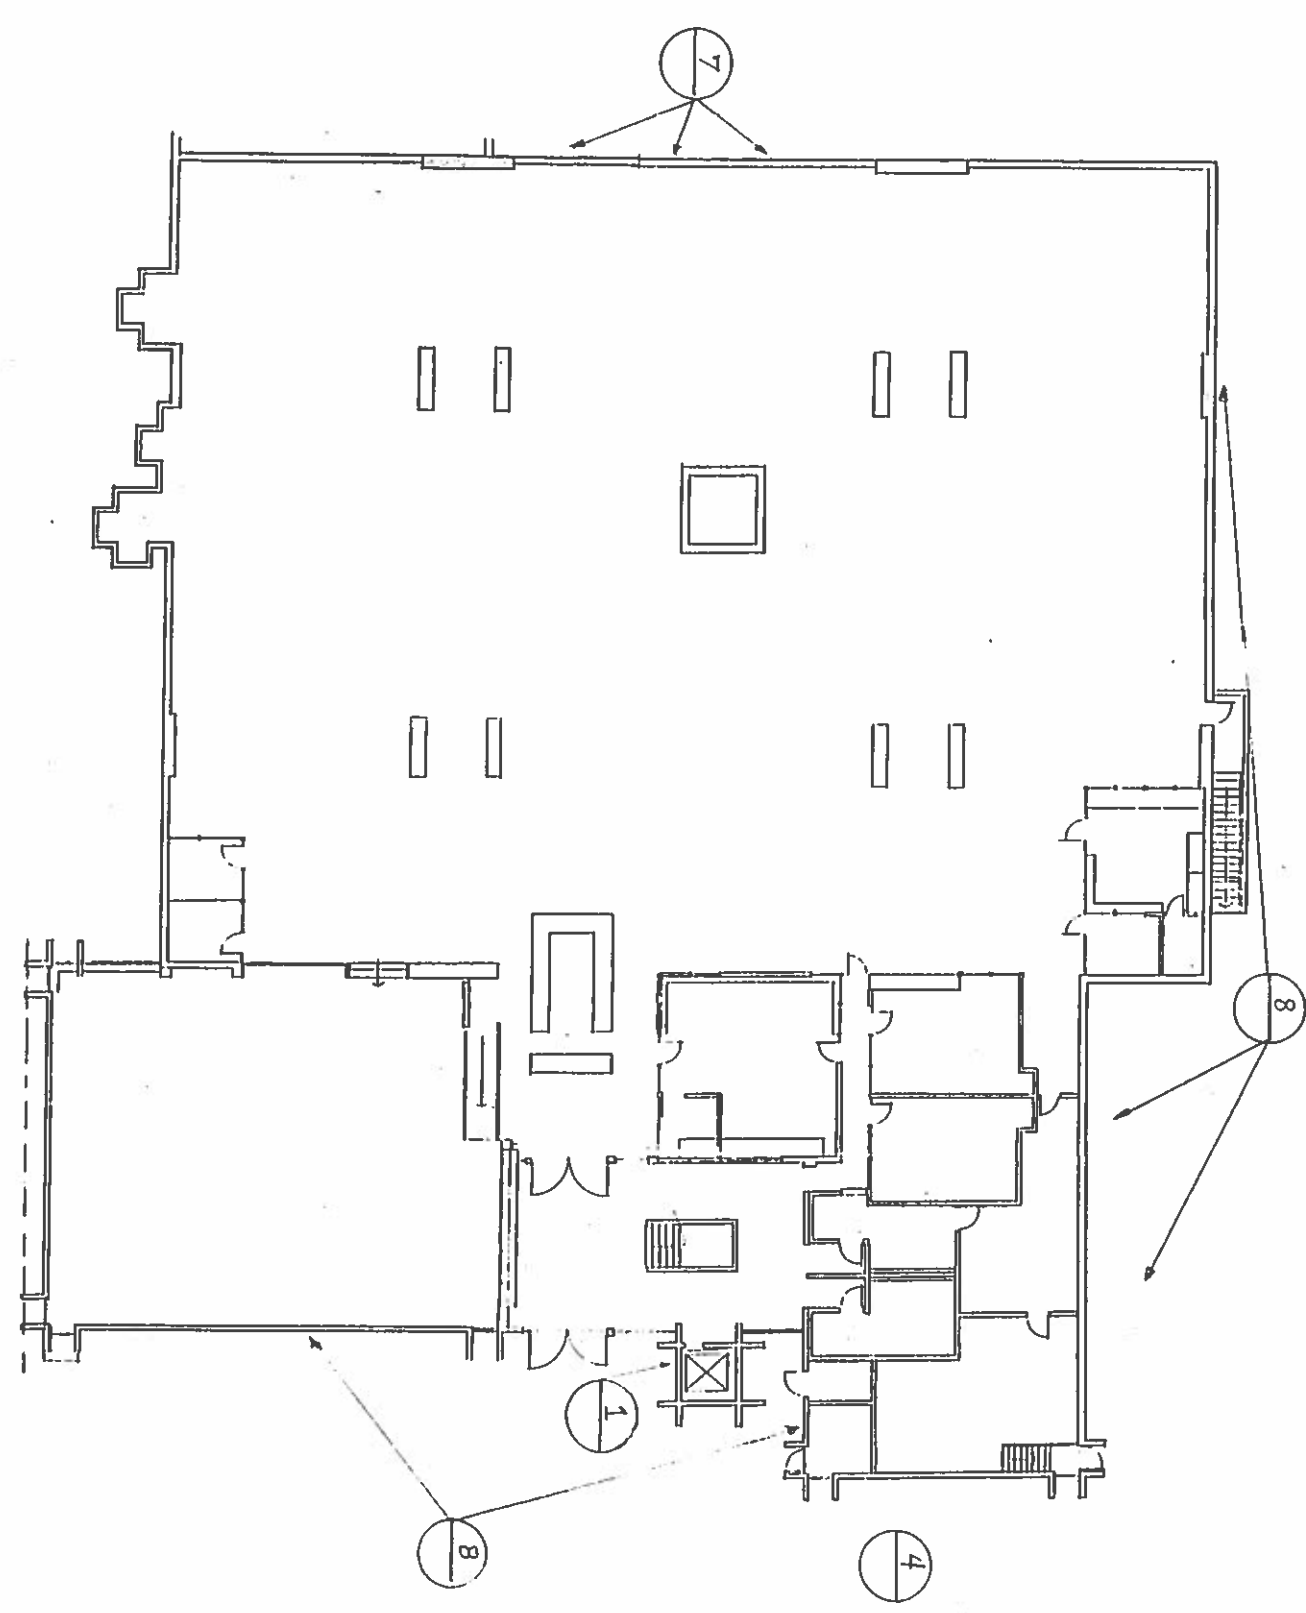
FIRST FLOOR PLAN

WORK ITEM NO. 5 REF. DWG. NO. 0 SYSTEM NO. 1.1-04	DESIGN CONSTRUCT	N/A 83	\$ _____	6	REATTACH TOILET COMPARTMENT PARTITIONS IN THE MEN'S RESTROOM TO PREVENT THE TEMPTATION TO FURTHER VANDALIZE.*	\$ 75
WORK ITEM NO. 6 REF. DWG. NO. 2 SYSTEM NO. 1.1-04	DESIGN CONSTRUCT	N/A 83	\$ _____	6	REMOVE SMALL CONCRETE RAMP FROM IN FRONT OF EXTERIOR STORAGE LOCKERS. THE CONCRETE RAMP HAS BROKEN LOOSE AND PRESENTS A TRIPPING HAZARD. NO NEED TO REPLACE.*	\$ 25
WORK ITEM NO. 7 REF. DWG. NO. 3 SYSTEM NO. 1.1-04	DESIGN CONSTRUCT	N/A 83	\$ _____	6	REATTACH BATHROOM FIXTURES IN RESTROOMS UPSTAIRS OFF HALL.*	\$ 25
WORK ITEM NO. 8 REF. DWG. NO. 0 SYSTEM NO. 1.1-04	DESIGN CONSTRUCT	N/A 84	\$ _____	6	CLEAN LINEAR DIFFUSERS IN ENTRY FOYER. IF THEY HAVE BEEN SUBJECT TO RUST: SCRAPE, SAND, PRIME AND PAINT WITH RUST INHIBITIVE PAINT.*	\$ 225

REF. NO	TASK	YEAR	AUTH.AMT	RATING	DESCRIPTION	COST
WORK ITEM NO. 9 REF. DWG. NO. 4 SYSTEM NO. 1.1-04	DESIGN CONSTRUCT	N/A 84	\$ _____	6	REATTACH BROKEN LOUVER AT LOCATION SHOWN ON DRAWING.*	\$ 25
WORK ITEM NO. 10 REF. DWG. NO. 0 SYSTEM NO. 2.3-22	DESIGN CONSTRUCT	N/A 87	\$ _____	6	REGRADE THE EARTH ALONG THE WEST AND SOUTHWEST EXTERIOR WALLS OF THE LIBRARY. THE DAMPNESS WILL CAUSE A GRADUAL DETERIORATION TO THE CONCRETE WALLS, SLAB AND ALUMINUM SASH.*	\$ 875
WORK ITEM NO. 11 REF. DWG. NO. 5 SYSTEM NO. 2.8-40	DESIGN CONSTRUCT	N/A 86	\$ _____	10	REPLANT PLANTER AREA ADJACENT TO BOOKDROP AT UPPER LEVEL. SUGGEST USE OF "CATALINA CURRENT", A NATIVE MOUNDING SCRUB WHICH WILL SURVIVE ON NATURAL RAINFALL AFTER ESTABLISHMENT PERIOD. THIS WILL PREVENT FURTHER WATER DAMAGE TO THE AREAS BELOW.*	\$ 175
WORK ITEM NO. 12 REF. DWG. NO. 0 SYSTEM NO. 7.1-20	DESIGN CONSTRUCT	83 84	\$ _____	3	RECAULK AT BASE OF ALL EXTERIOR WALLS WHERE WALL MEETS DECK SLAB TO PREVENT FURTHER WATER DAMAGE. A PROPER SPECIFICATION FOR THE APPLICATION METHOD AND CAULK TYPE SHOULD BE PREPARED.*	\$ 1600

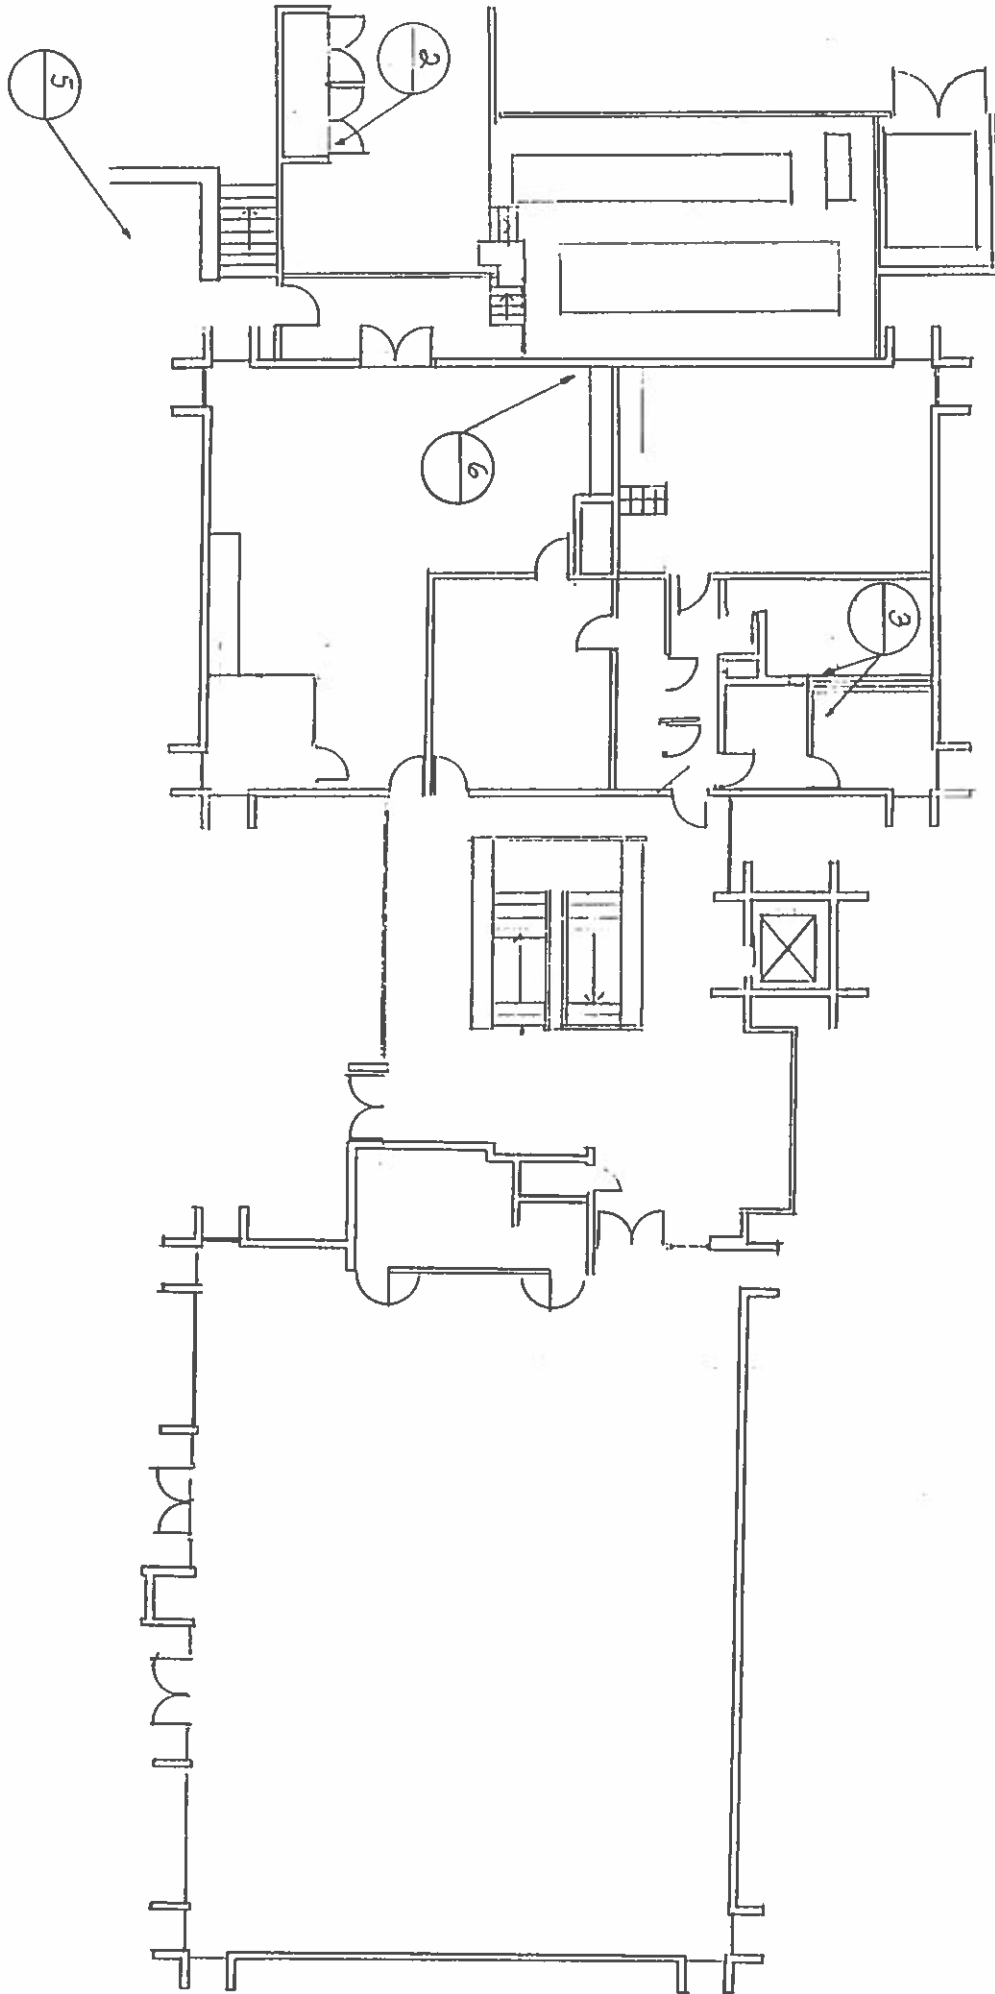
UPPER FLOOR PLAN

REF. NO	TASK	YEAR	AUTH. AMT	RATING	DESCRIPTION	'83 COST
WORK ITEM NO. 15 REF. DWG. NO. 6 SYSTEM NO. 7.8-20	DESIGN CONSTRUCT	N/A 83	\$ _____	8	REPAIR DAMAGE TO ROOF ENTRY HATCH OVER "FRIENDS" STORAGE ROOM. REINFORCE HATCH IF NECESSARY.*	\$ 50
WORK ITEM NO. 16 REF. DWG. NO. 0 SYSTEM NO. 8.4	DESIGN CONSTRUCT	86 87	\$ _____	10	REPLACE SIMULATED WOOD FORMICA INTERMEDIATE HORIZONTAL TRIM WHICH IS USED THROUGHOUT EXTERIOR OF LIBRARY AS A WINDOW GUARD DETAIL. FORMICA CAN NOT TAKE EXPOSURE TO EXTERIOR ELEMENTS. IT IS IN VARIOUS STATES OF DETERIORATION. REPLACE WITH EXTRUDED ALUMINUM WHICH HAS AN ANODIZING WITH THE SAME COLOR VALUE.*	\$ 2900
WORK ITEM NO. 17 REF. DWG. NO. 0 SYSTEM NO. 8.4-60	DESIGN CONSTRUCT	86 87	\$ _____	6	ENTRY DOORS AT THE MAIN BASEMENT ENTRY TO THE LIBRARY ARE OF IMPROPER DESIGN OR MANUFACTURE. NEW DOORS WITH MORE SUBSTANTIAL INTERNAL BRACING, BETTER SECURITY, AND GREATER BASE OF OPERATION (HANDICAPPED - 7 POUNDS ENTRY PRESSURE) SHOULD BE DESIGNED AND INSTALLED.*	\$ 4800

REF. NO	TASK	YEAR	AUTH.AMT	RATING	DESCRIPTION	'83 COST
WORK ITEM NO. 20	DESIGN CONSTRUCT	N/A	\$ _____	6	PROPER SOLUTION WOULD REQUIRE A BRIEF ANALYSIS BY AN ACCOUSTICAL ENGINEER (APPROXIMATE FEE \$400).*	
REF. DWG. NO. 7						
SYSTEM NO. 9.8-20						
WORK ITEM NO. 21	DESIGN CONSTRUCT	N/A	\$ _____	6	PATCH, PREPARE AND PAINT EXTERIOR FLAKING STUCCO REVEAL AT RAMP AND BACK LIBRARY WALL. RECAULK ALONG BASE.*	\$ 225
REF. DWG. NO. 0						
SYSTEM NO. 9.8-20						
WORK ITEM NO. 22	DESIGN CONSTRUCT	N/A	\$ _____	6	PATCH AND PAINT HOLES DRILLED FOR ACCESSORIES IN ALL RESTROOMS; PATCH AND PAINT AREA BEHIND JANITOR'S SINK IN ELECTRICAL VAULT AND PAINT ROOM AS NEEDED.*	\$ 400
REF. DWG. NO. 0						
SYSTEM NO. 9.8-20						
WORK ITEM NO. 23	DESIGN CONSTRUCT	N/A	\$ _____	6	PREPARE AND PAINT THE FOLLOWING METAL SURFACES TO PREVENT FURTHER RUSTING: LIGHT FIXTURE TRIM FOR EXTERIOR FIXTURES LOCATED UNDER EAVES; EXTERIOR SPEAKER GRILLS; METAL GATES AT REAR OF LIBRARY.*	\$ 175

REF. DWG. NO. 0						
SYSTEM NO. 9.8-20						
WORK ITEM NO. 24	DESIGN CONSTRUCT	N/A	\$ _____	3	REPAINT EXTERIOR STUCCO AT ALL EXTERIOR LOCATIONS.*	\$ 2300
REF. DWG. NO. 8						
SYSTEM NO. 9.8-20						
WORK ITEM NO. 25	DESIGN CONSTRUCT	N/A	\$ _____	6	PREPARE AND PAINT ALL EXTERIOR METAL GUARD AND HANDRAILS. THE TYPE OF PAINT AND APPLICATION SPECIFICATION SHOULD BE PREPARED JUST PRIOR TO PAINTING.*	\$ 1100
REF. DWG. NO. 0						
SYSTEM NO. 9.8-20						
WORK ITEM NO. 26	DESIGN CONSTRUCT	N/A	\$ _____	10	REPLACE STREET NUMBERS BELOW BRASS LIBRARY SIGN WITH NUMBERS MORE APPROPRIATE IN SIZE AND DESIGN.*	\$ 150
REF. DWG. NO. 0						
SYSTEM NO. 10.1-77						
WORK ITEM NO. 27	DESIGN CONSTRUCT	N/A	\$ _____	6	SERVICE BACKFLOW PREVENTER TO ELIMINATE LEAK AT NORTHWEST CORNER OF SITE.*	\$ 50
REF. DWG. NO. 0						
SYSTEM NO. 15.1-04
