FACILITY CONDITION ASSESSMENT

City of Glendora
116 East Foothill Boulevard
Glendora, California 91741
Michael Sledd

City Baseball Field at Manooshian
#AIN 8648001800 (857 North Loraine Avenue)
Glendora, California 91741

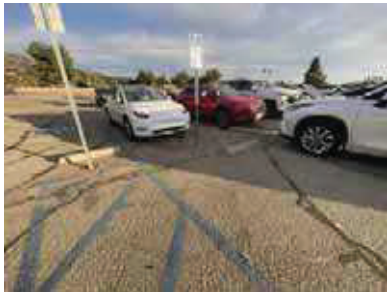
Parking Lots in Poor condition.

Pavement, Asphalt
City Baseball Field at Manooshian Site

Striping is faded - AssetCALC ID: 7189604

Uniformat Code: G2020
Recommendation: **Seal and Stripe in 2023**

Cost Estimate: \$29,800

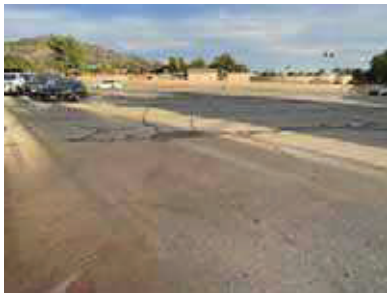
Parking Lots in Poor condition.

Pavement, Asphalt
City Baseball Field at Manooshian Site

Surface deterioration, sealed longitudinal cracks - AssetCALC ID: 7049626

Uniformat Code: G2020
Recommendation: **Mill and Overlay in 2025**

Cost Estimate: \$231,500

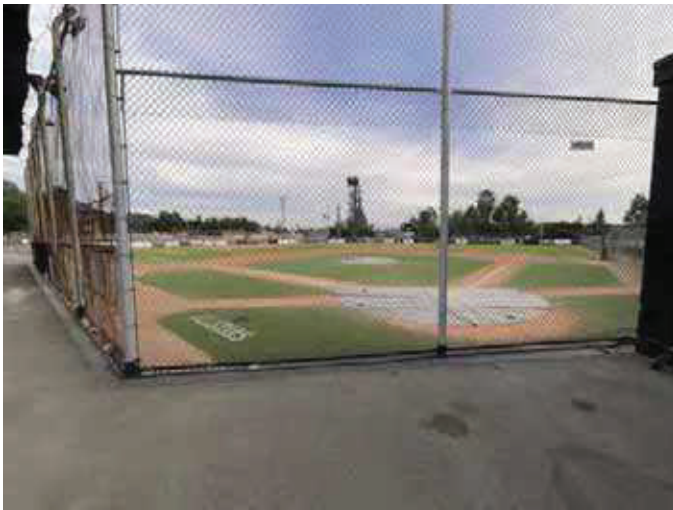
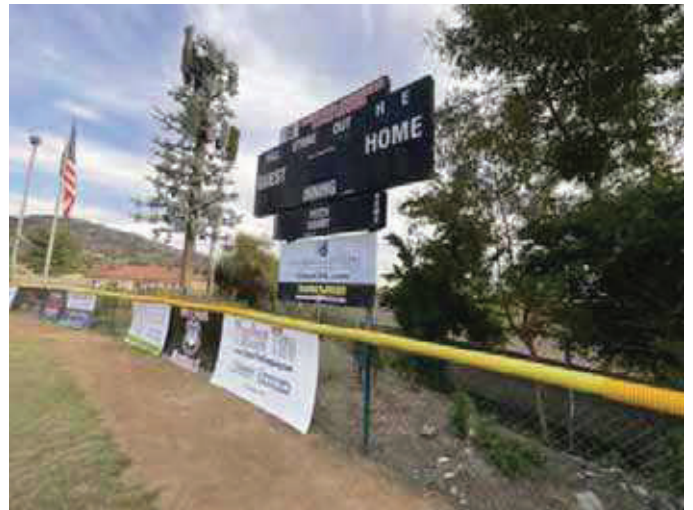
B-6. Baseball Field

Asset Type	Baseball Field		
Asset Location	857 North Loraine Avenue. Glendora, California 91741		
Overall Condition	Fair		
<i>Component</i>	<i>Description</i>	<i>Quantity</i>	<i>Condition</i>
Landscaping and Topography	Limited landscaping features; irrigation not present		
Storm Water Management	Surface drainage to developed surroundings		
Accessibility	Potential accessibility issues were not observed at this asset. Refer to Appendix D for more details.		
Key Issues and Findings	None

<i>Component</i>	<i>Description</i>	<i>Quantity</i>	<i>Condition</i>
Bleachers	Fixed Steel Frame, Aluminum Benches (per Seat), Replace	550 EA	Fair
Fences & Gates	Fence, Chain Link 4', Replace	360 LF	Fair

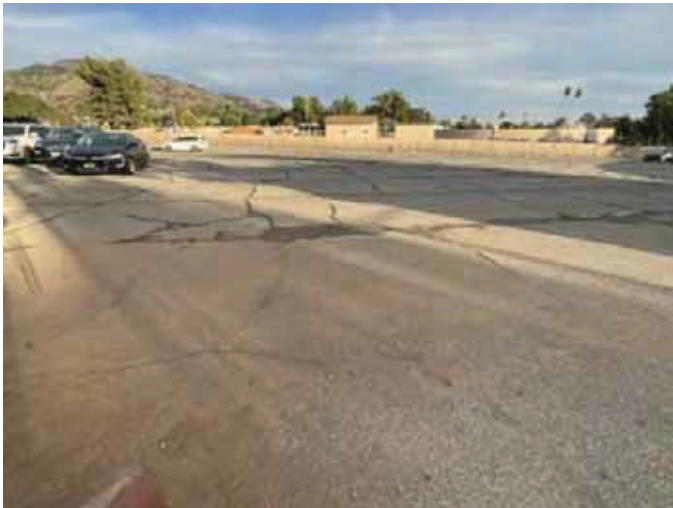
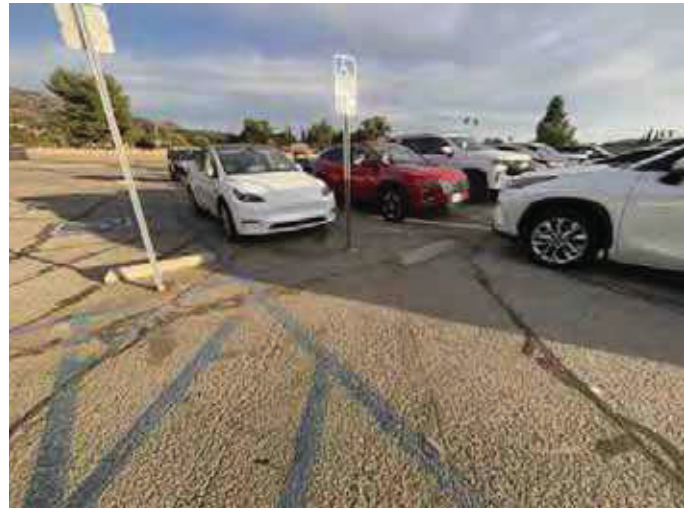
B-7. General Site

Asset Type	Parking Lot		
Asset Location	East portion of site		
Overall Condition	Poor		
<i>Component</i>	<i>Description</i>	<i>Quantity</i>	<i>Condition</i>
Parking Lots	Pavement, Asphalt, Mill and Overlay	49000 SF	Poor
Parking Lots	Pavement, Asphalt, Seal and Stripe	49000 SF	Poor
