# FACILITY CONDITION ASSESSMENT & ENERGY AUDIT

**City of Glendora**  
116 East Foothill Boulevard  
Glendora, California 91741  
Michael Sledd

*February 19, 2024*

Big Dalton Canyon Park Daycamp/Restrooms  
2041 Big Dalton Canyon Road  
Glendora, California 91741

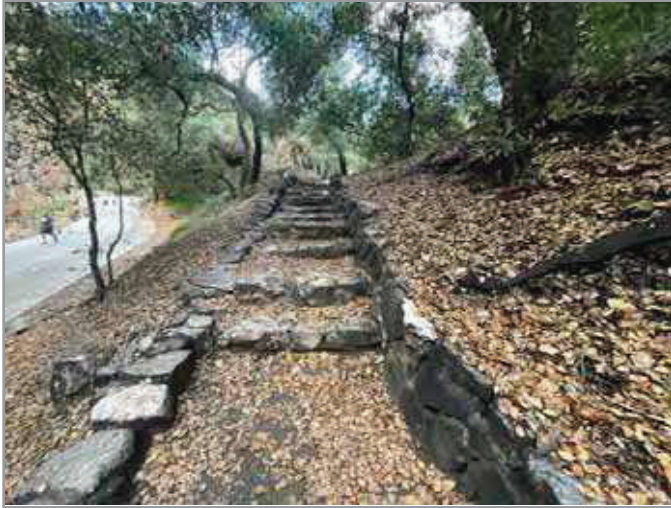
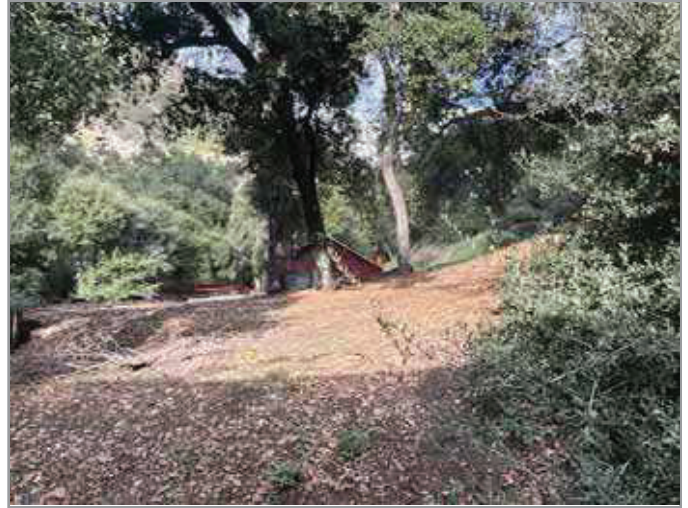
ACCESSIBLE PATH

2ND PATHWAY

Question		Yes	No	NA	Comments
1	Is an accessible route present from public transportation stops and municipal sidewalks on or immediately adjacent to the property ?		✗		
2	Does a minimum of one accessible route appear to connect all public areas on the exterior, such as parking and other outdoor amenities, to accessible building entrances ?			✗	
3	Are curb ramps present at transitions through raised curbs on all accessible routes?			✗	
4	Do curb ramps appear to have compliant slopes for all components ?			✗	
5	Do ramp runs on an accessible route appear to have compliant slopes ?			✗	
6	Do ramp runs on an accessible route appear to have a compliant rise and width ?			✗

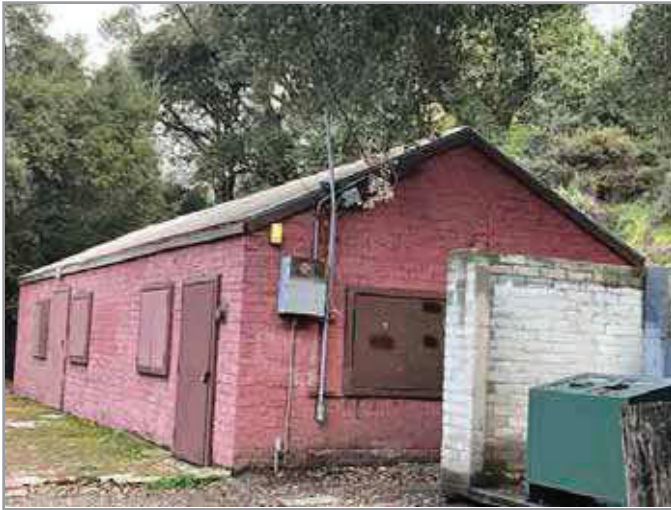
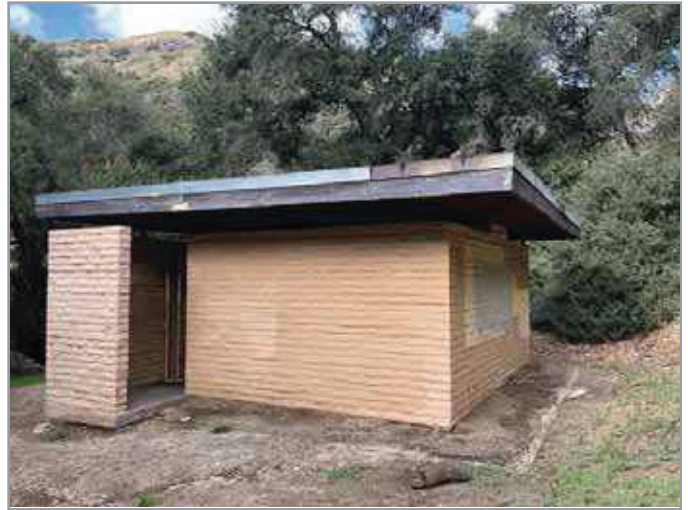
ACCESSIBLE ENTRANCE

ADDITIONAL ENTRANCE

Question		Yes	No	NA	Comments
1	Do a sufficient number of accessible entrances appear to be provided ?		X		
2	If the main entrance is not accessible, is an alternate accessible entrance provided?			X	
3	Is signage provided indicating the location of alternate accessible entrances ?			X	
4	Do doors at accessible entrances appear to have compliant maneuvering clearance area on each side ?			X	
5	Do doors at accessible entrances appear to have compliant hardware ?			X	
6	Do doors at accessible entrances appear to have a compliant clear opening width ?			X

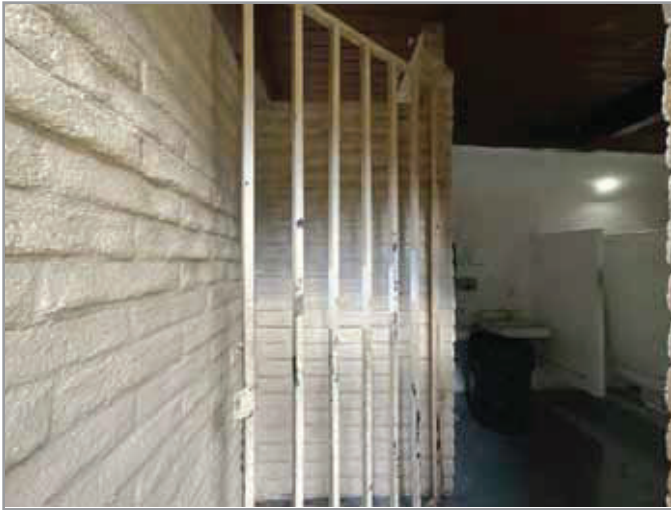
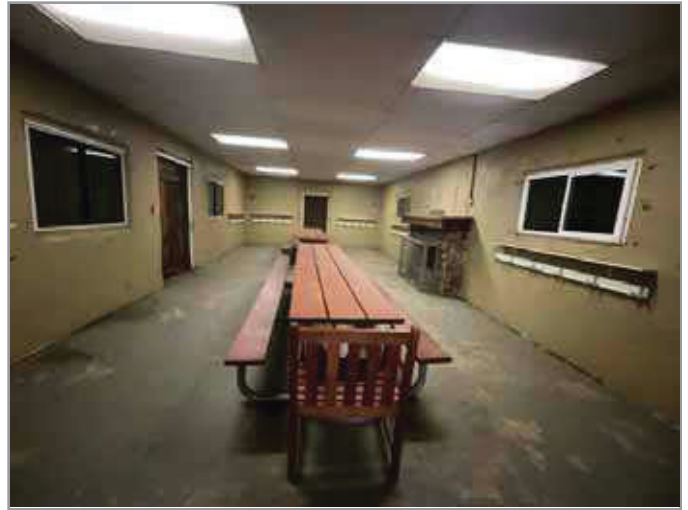
DOOR HARDWARE

ACCESSIBLE INTERIOR PATH

Question		Yes	No	NA	Comments
1	Does an accessible route appear to connect all public areas inside the building ?	✗			
2	Do accessible routes appear free of obstructions and/or protruding objects ?	✗			
3	Do ramps on accessible routes appear to have compliant slopes ?	✗			
4	Do ramp runs on an accessible route appear to have a compliant rise and width ?			✗	
5	Do ramps on accessible routes appear to have compliant end and intermediate landings ?			✗	
6	Do ramps on accessible routes appear to have compliant handrails ?			✗

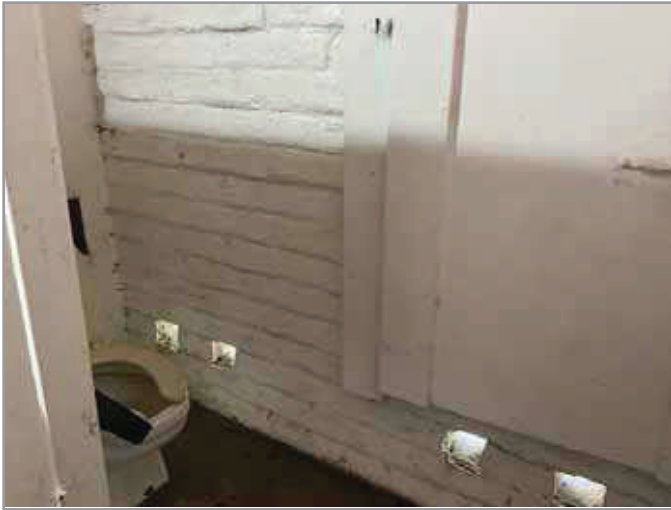
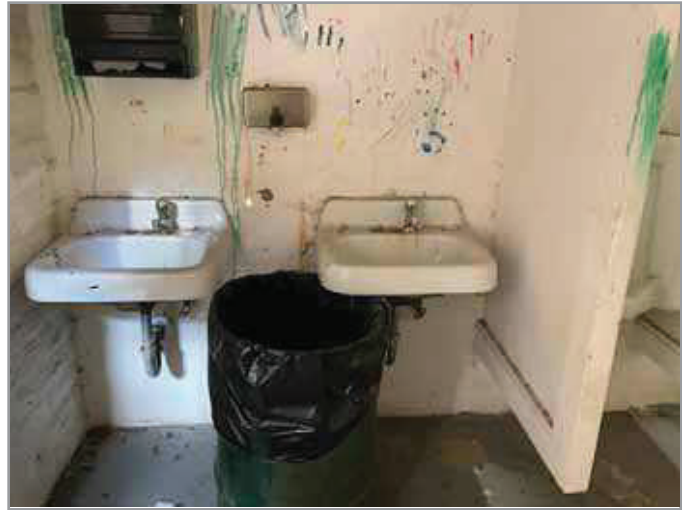
TOILET STALL OVERVIEW

SINK, FAUCET HANDLES AND ACCESSORIES

Question		Yes	No	NA	Comments
1	Do publicly accessible toilet rooms appear to have a minimum compliant floor area ?		✗		
2	Does the lavatory appear to be mounted at a compliant height and with compliant knee area ?		✗		
3	Does the lavatory faucet have compliant handles ?		✗		
4	Is the plumbing piping under lavatories configured to protect against contact ?		✗		
5	Are grab bars provided at compliant locations around the toilet ?		✗		
6	Do toilet stall doors appear to provide the minimum compliant clear width ?		✗
