FACILITY CONDITION ASSESSMENT & ENERGY AUDIT

La Fetra Senior Center
333 East Foothill Boulevard
Glendora, California 91741

February 16, 2024

December 11, 2023

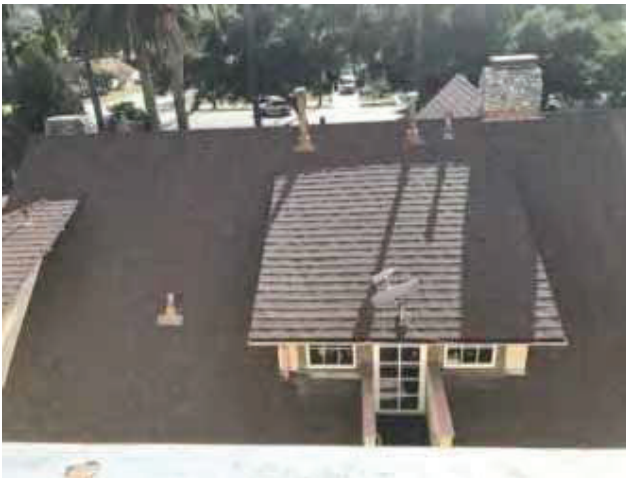
9 - SLOPED ASPHALT SHINGLE ROOFING

Mature tree growth over asphalt roof. Trimming is recommended to prevent damage to roof. - AssetCALC ID: 7162775

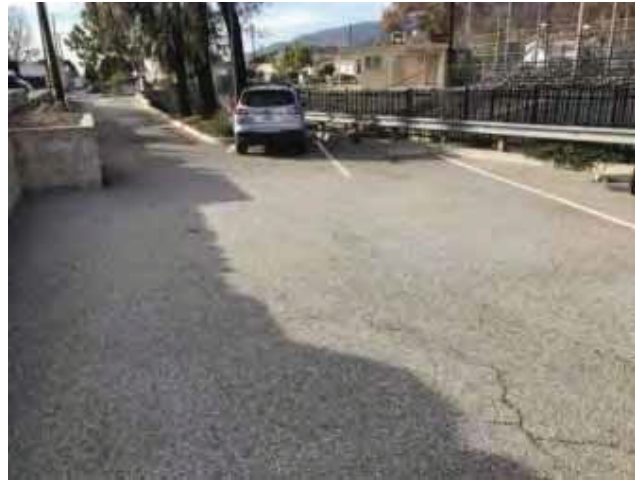
22 - ASPHALT PAVED PARKING LOT

Isolated locations of asphalt cracking - AssetCALC ID: 7162802

Uniformat Code: G2020
Recommendation: **Seal and Stripe in 2025**

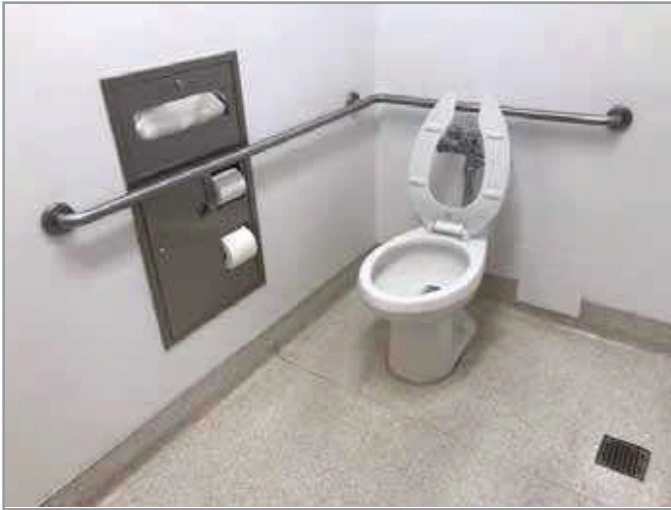
TOILET STALL OVERVIEW

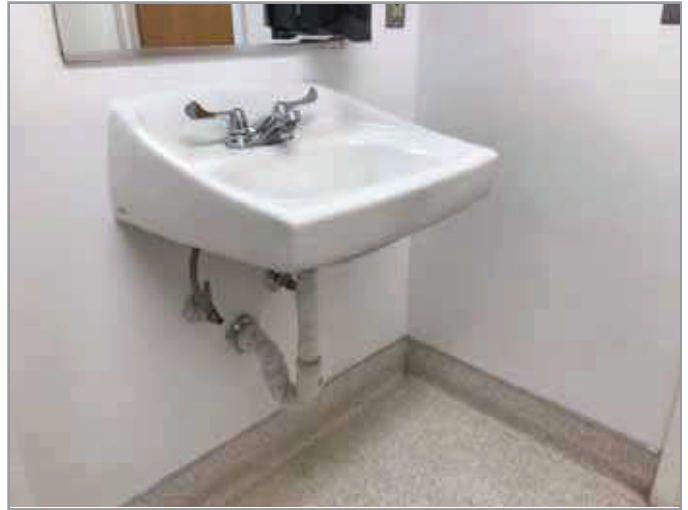
SINK, FAUCET HANDLES AND ACCESSORIES
