# FACILITY CONDITION ASSESSMENT & ENERGY AUDIT

**City of Glendora**  
116 East Foothill Boulevard  
Glendora, California 91741  
Michael Sledd

Ole Hammer Park  
359 North Live Oak Avenue  
Glendora, California 91741

*February 19, 2024*

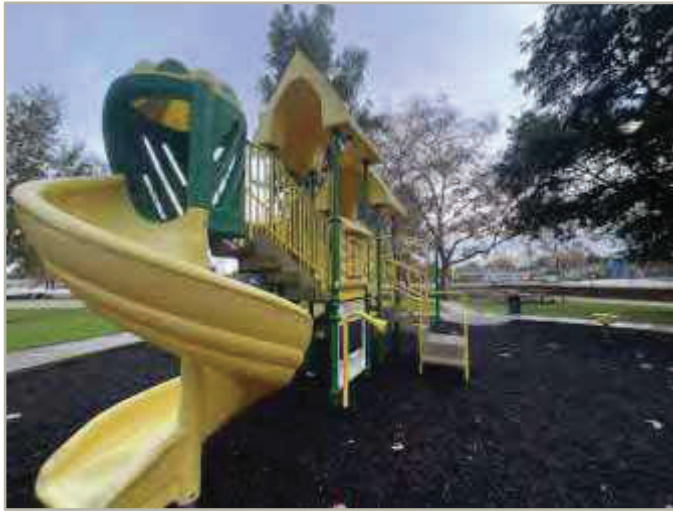
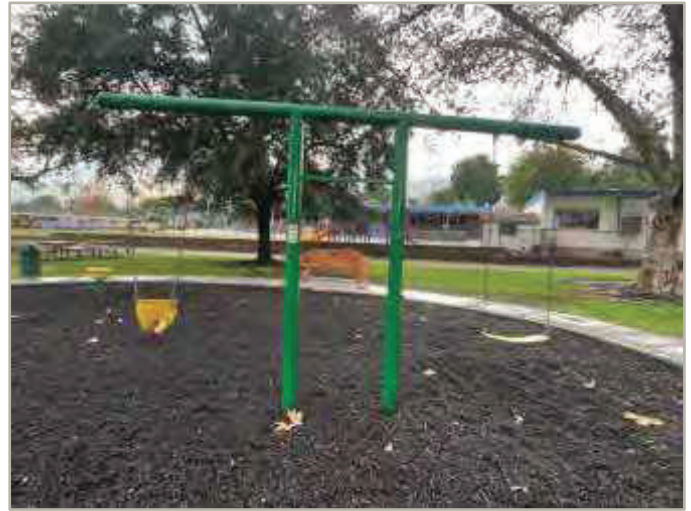
<b>Amenity Type</b>	Playground		
<b>Amenity Location</b>	Park center		
<b>Overall Condition</b>	Fair		
<i>Component</i>	<i>Description</i>	<i>Quantity</i>	<i>Condition</i>
<b>Play Structure</b>	Multipurpose, Small	2 EA	Fair
<b>Play Structure</b>	Multipurpose, Medium	1 EA	Fair
<b>Playground Surfaces</b>	Rubber, Chips 3" Depth	3000 SF	Fair / etc
<b>Key Issues and Findings</b>	Absence of lighting

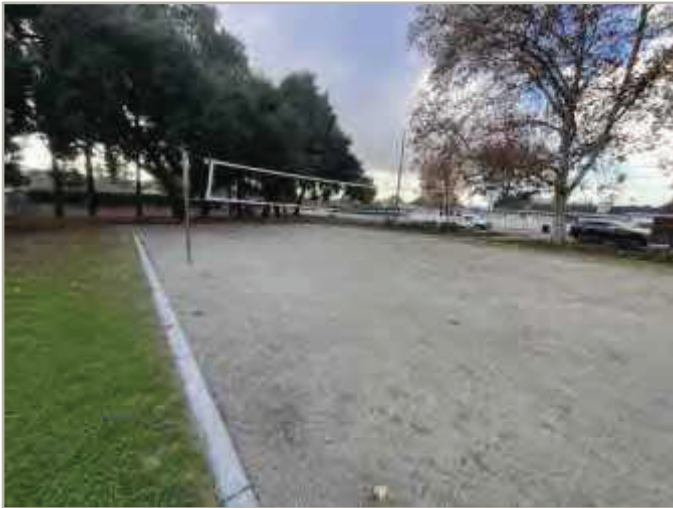
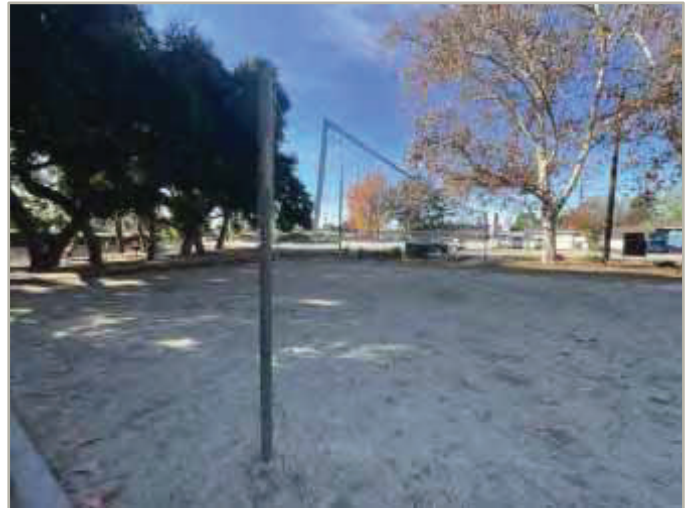
<b>Amenity Type</b>	Athletic Courts		
<b>Amenity Location</b>	Park East or Park Front Elevation		
<b>Overall Condition</b>	Fair		
<i>Component</i>	<i>Description</i>	<i>Quantity</i>	<i>Condition</i>
<b>Playfield Surfaces</b>	Sand, 3" Depth	3000 SF	Fair
<b>Sports Apparatus</b>	Volleyball, Net with Posts and Anchors	1 EA	Fair
<b>Key Issues and Findings</b>	Absence of lighting

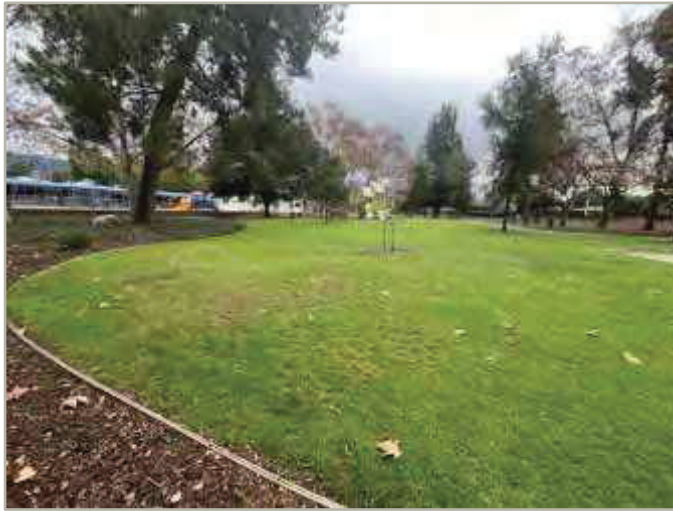
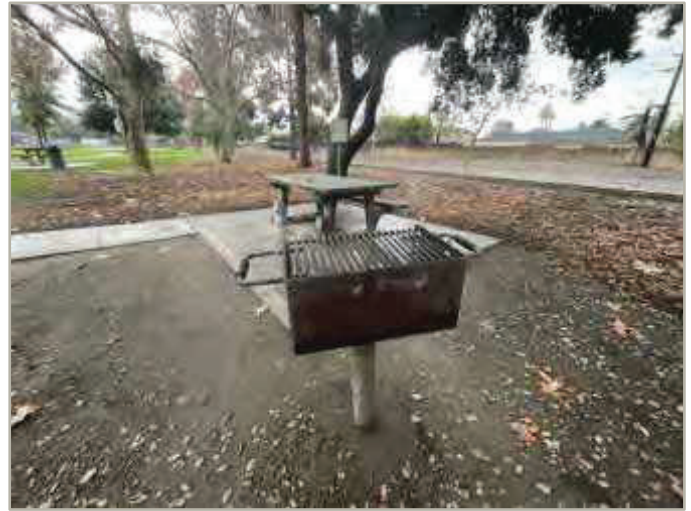
<b>Amenity Type</b>	General Site		
<b>Amenity Location</b>	Throughout park		
<b>Overall Condition</b>	Fair		
<i>Component</i>	<i>Description</i>	<i>Quantity</i>	<i>Condition</i>
<b>Drinking Fountain</b>	Site	1 EA	Poor
<b>Park Bench</b>	Precast Concrete	2 EA	Fair
<b>Campground Accessories</b>	Grill, Pedestal-Style	2 EA	Fair
<b>Picnic Table</b>	Wood	2 EA	Fair
<b>Picnic Table</b>	Precast Concrete	3 EA	Fair
<b>Trash Receptacle</b>	Medium-Duty Metal	4 EA	Fair
<b>Bollard</b>	Plastic	2 EA	Fair
<b>Backflow Preventer</b>	Domestic Water	1 EA	Fair

<b>General Site</b>			
<b>Portable Toilet</b>	Ancillary Building	1 EA	Fair
<b>Fences and Gates</b>	Fence, Metal Tube 6'	20 LF	Fair
<b>Sidewalk</b>	Concrete, Large Areas	10000 SF	Fair
<b>Sidewalk</b>	Concrete, Small Areas	500 SF	Poor
<b>Landscaping and Topography</b>	Heavy landscaping features; irrigation present Low to moderate site slopes throughout		
<b>Storm Water Management</b>	Retention ponds		
<b>Key Issues and Findings</b>	Minor sidewalk cracking, absence of site lighting, malfunctioning drinking fountain
